**Breathing Life into Hardwood  
Bridge Trusses:  
*A Marriage of Steel and Timber***

**Ian Taylor, David Hutchison Downer EDI Works**

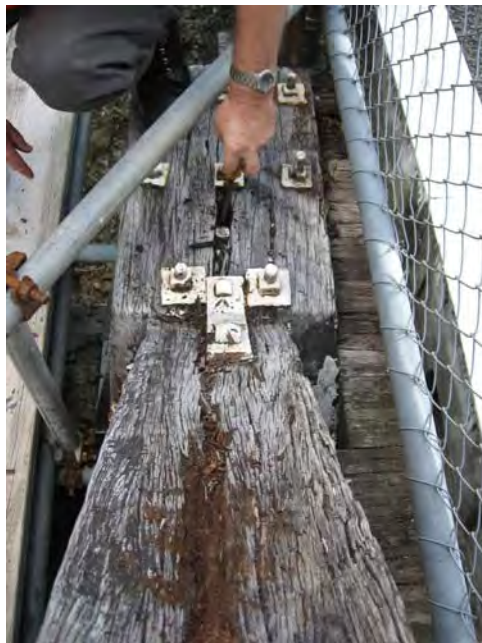
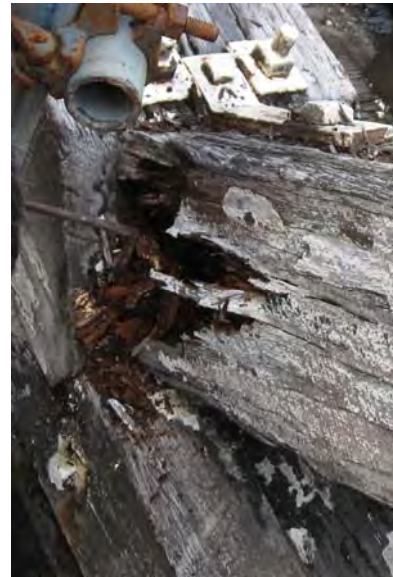
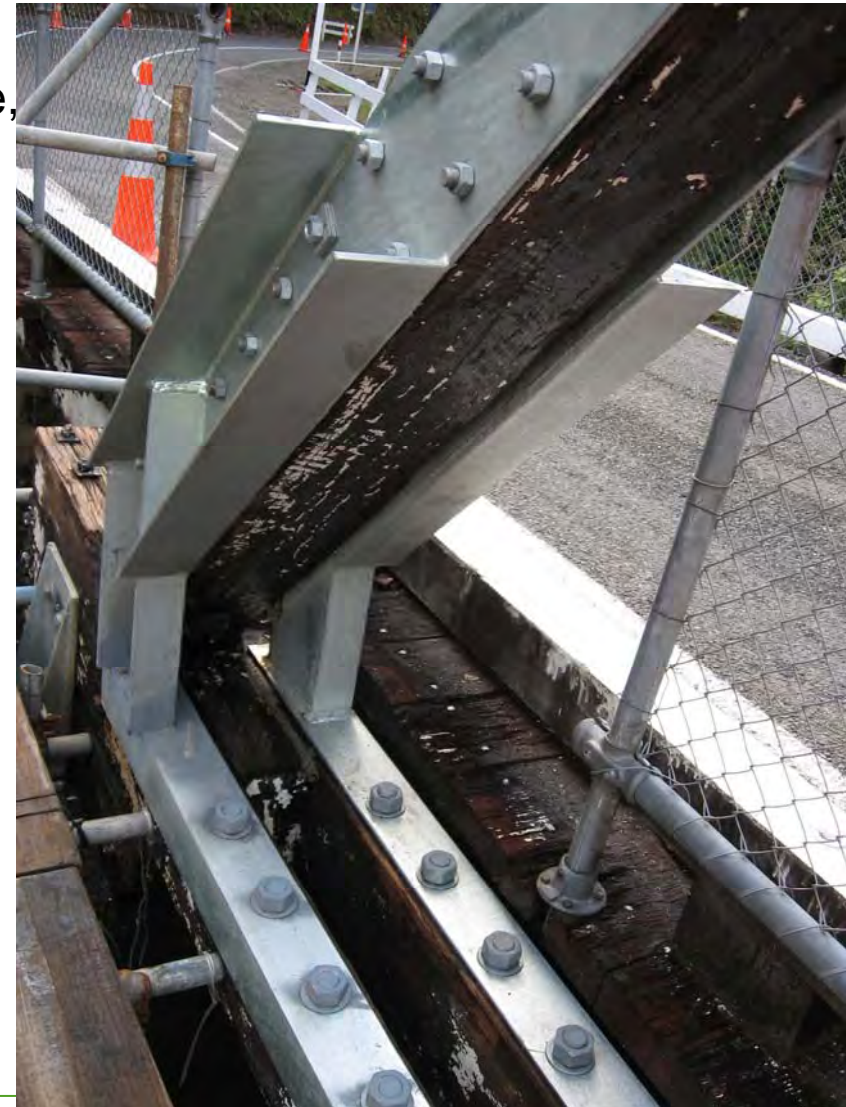
- In the picture below, the thrust block is split
- End diagonal post seriously decayed at base, –80% loss of end section
- Steel brace repair reacts thrust back into bottom chord

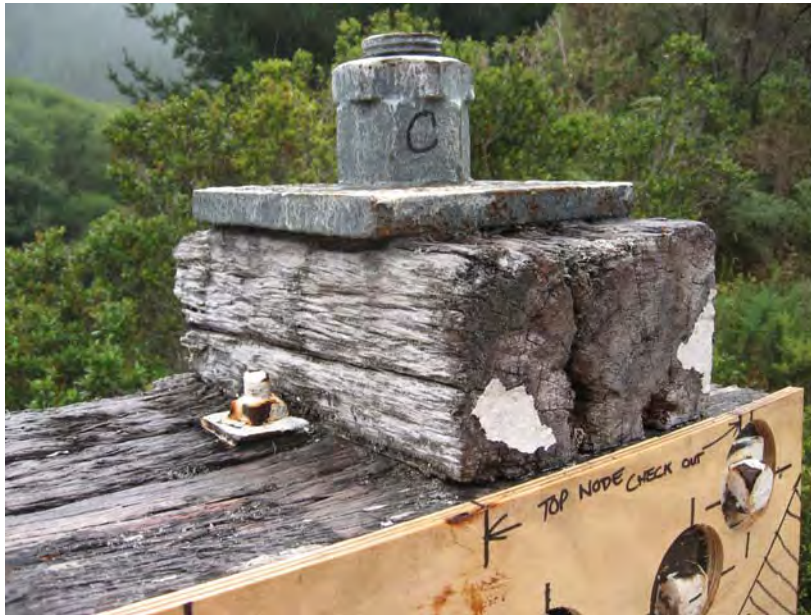
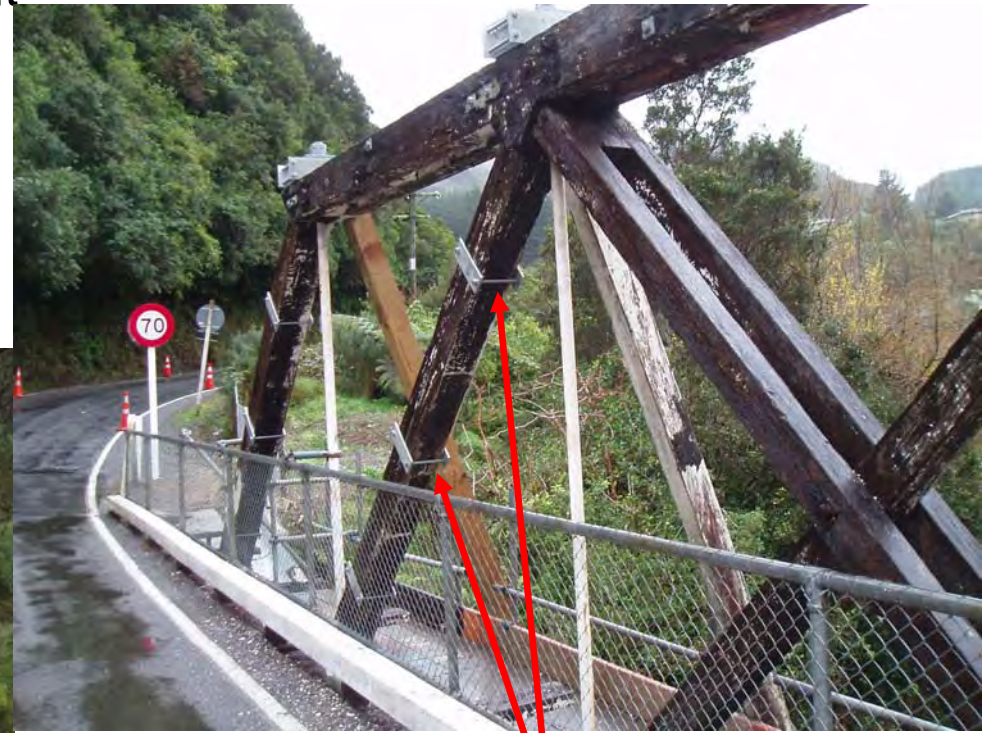
- Blocks reacting hanger load are split
- Unable to be replaced without unloading hangers
- Instead, strapped to provide hoop strength

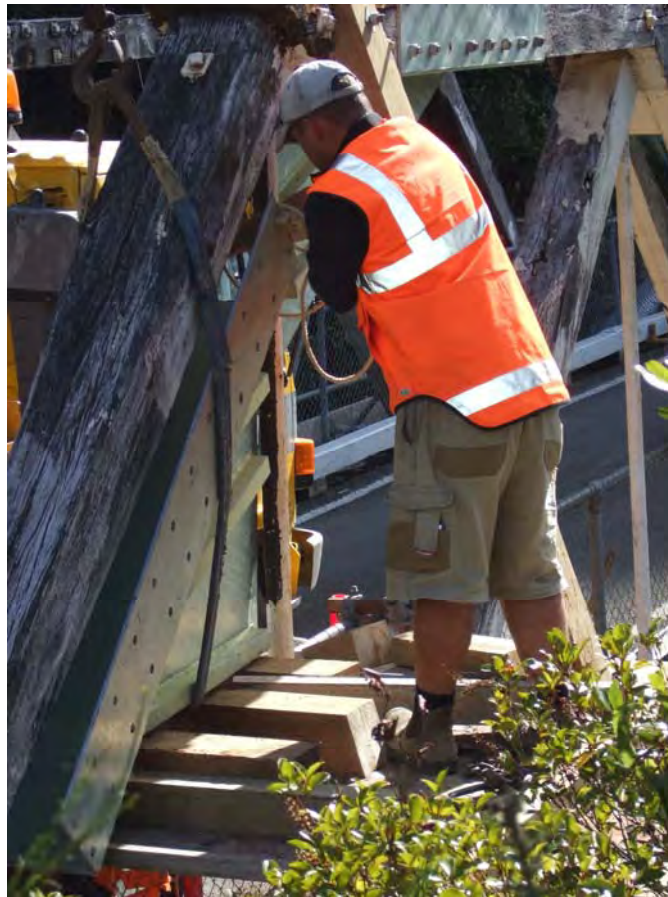
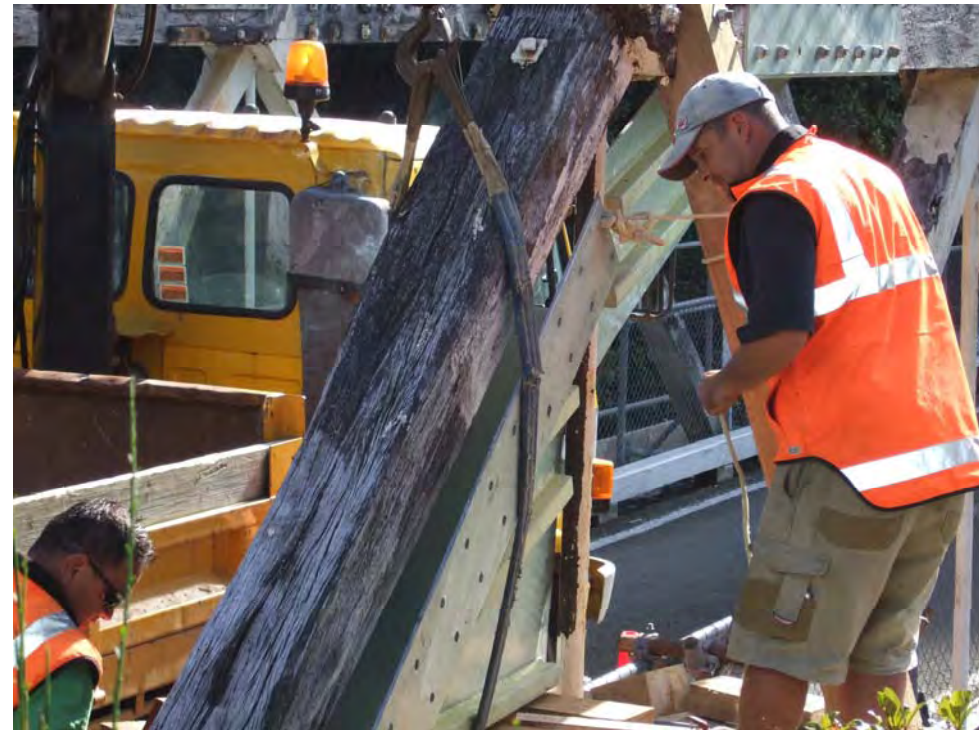
Site measurements for fitting were critical

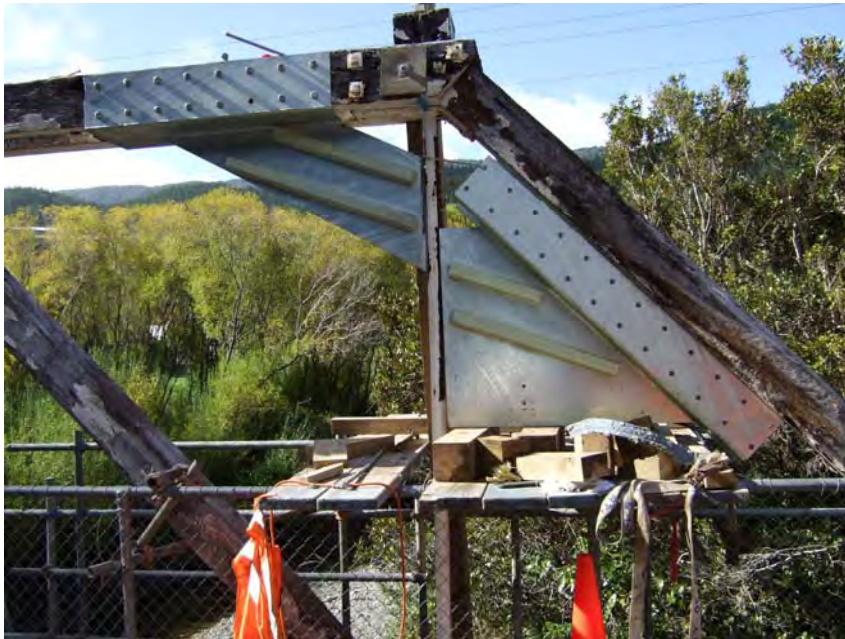
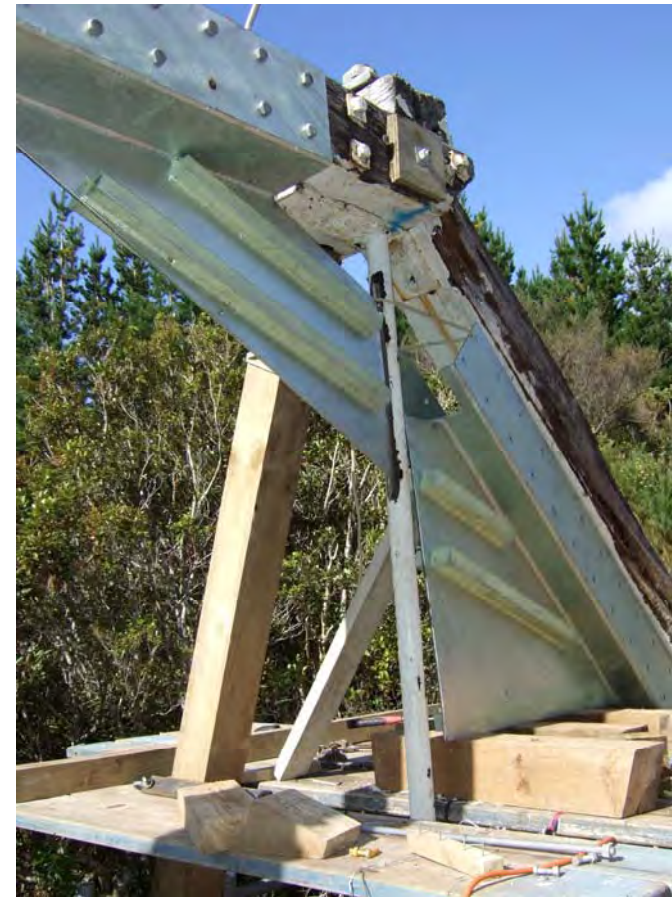
- Fitting two segments into position
- Then site welded to hanger

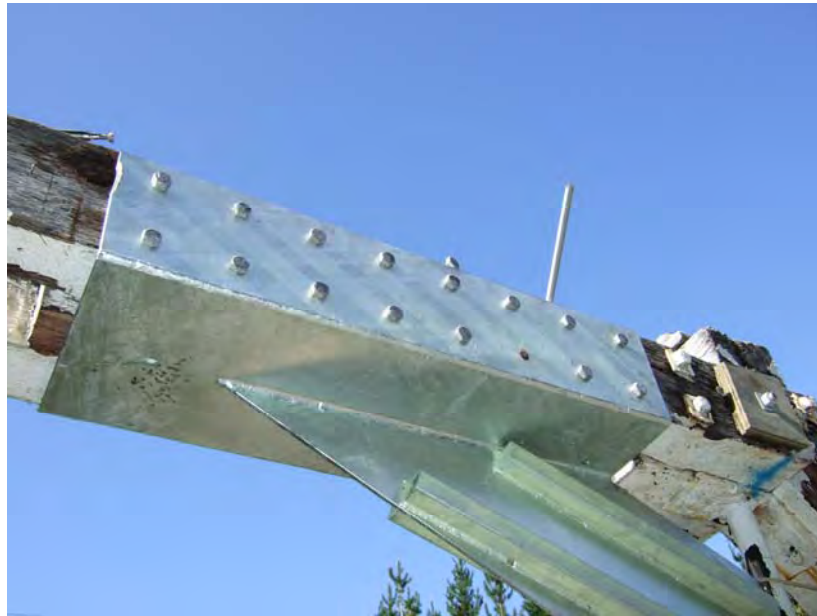
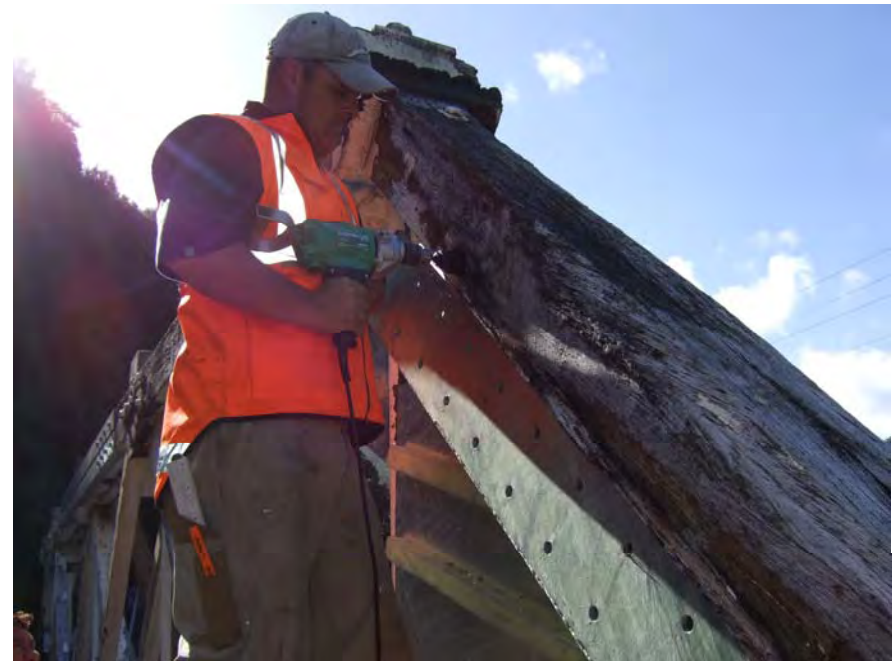
Coring 50 mm holes for ring connector
