# Flooding our Roads

A Study on Climate Change and Emulsion Stabilisation

# Foamed Bitumen flood resilience – Oakey-Pittsworth Road

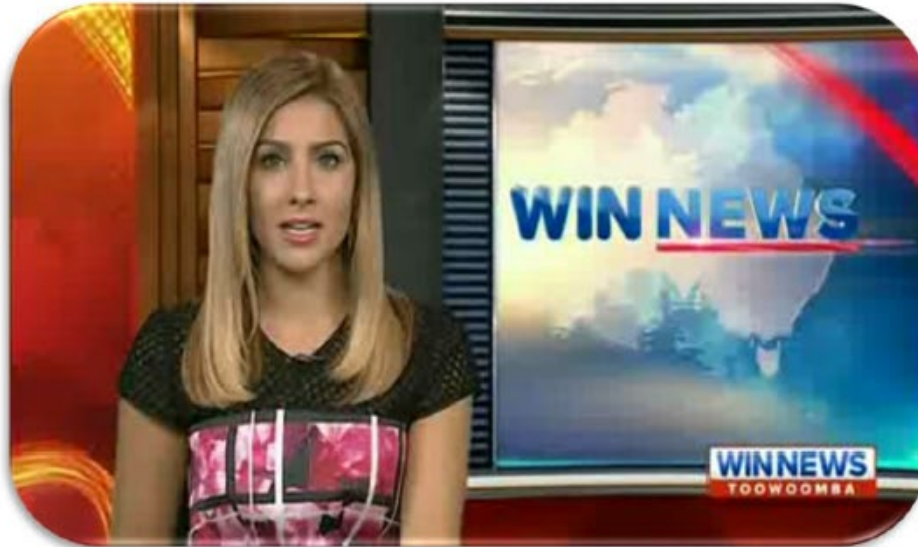
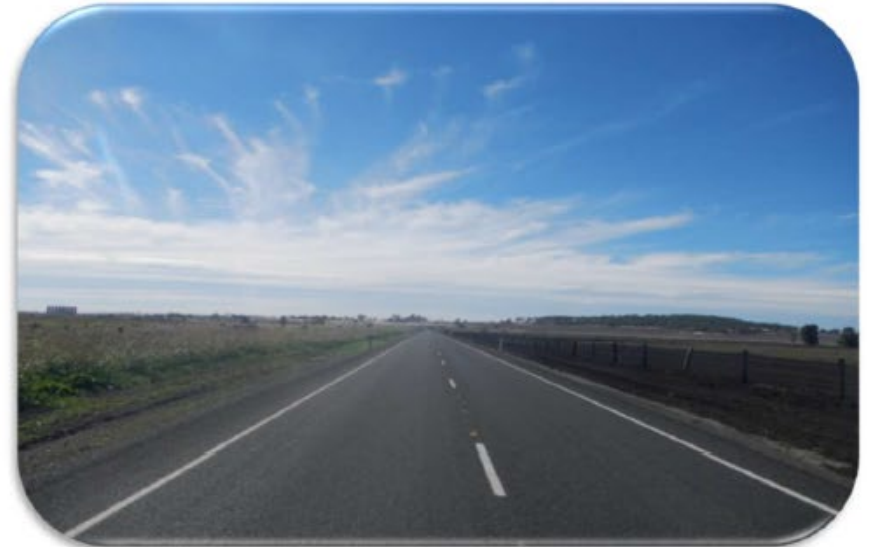
In 2014 after the Darling Downs communities were again inundated by floods, the Oakey-Pittsworth Road was the lead story on the local news. This road was in the process of being repaired following inundation in 2010 and 2011. After the 2010/11 events the road was closed for several days whilst repairs were undertaken and was speed and load restricted until rehabilitation in 2014. The news story reported that the road was able to be opened immediately after the flood waters receded. This was due to the use of the Foamed Bitumen Stabilisation treatment and permitted the road to connect communities immediately after being inundated by floods. This event was only days after the successful completion of rehabilitation.

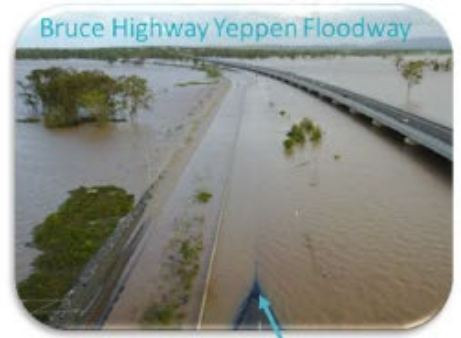
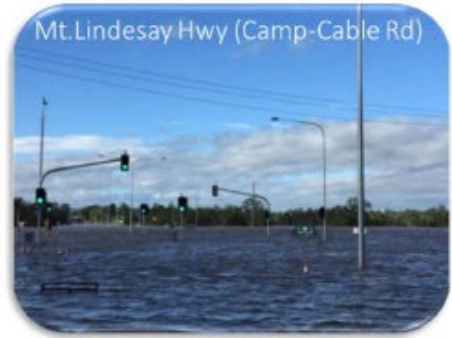
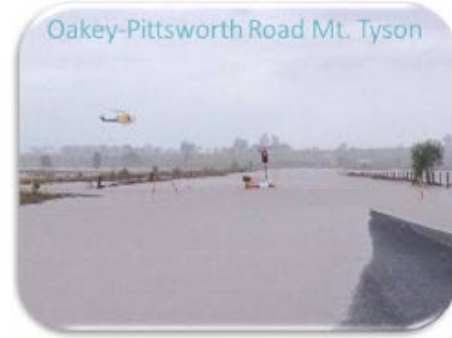
Foamed Bitumen

These foamed bitumen pavements survived unscathed after flooding from natural disasters in Queensland.

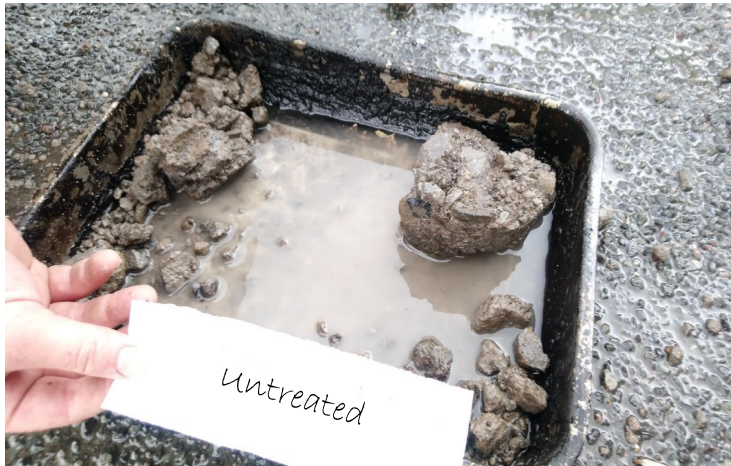
- Unbound base course
- Water-blasted
- Fines washed away
- Material blew out

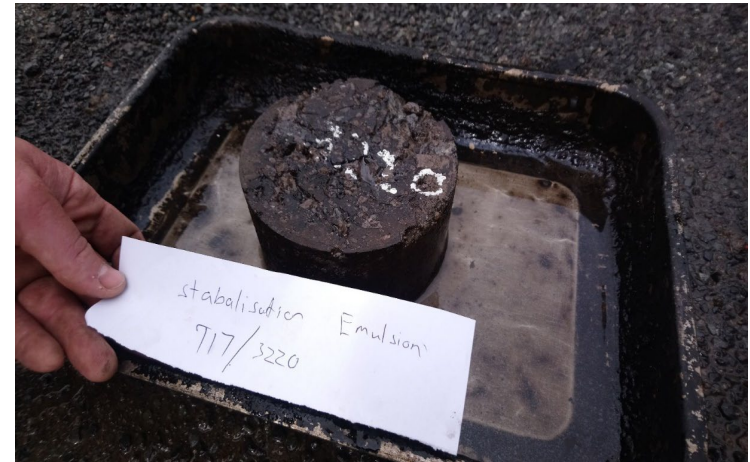
- Emulsion stabilised base course
- Water-blasted
- Fines remained intact
- Material performed well

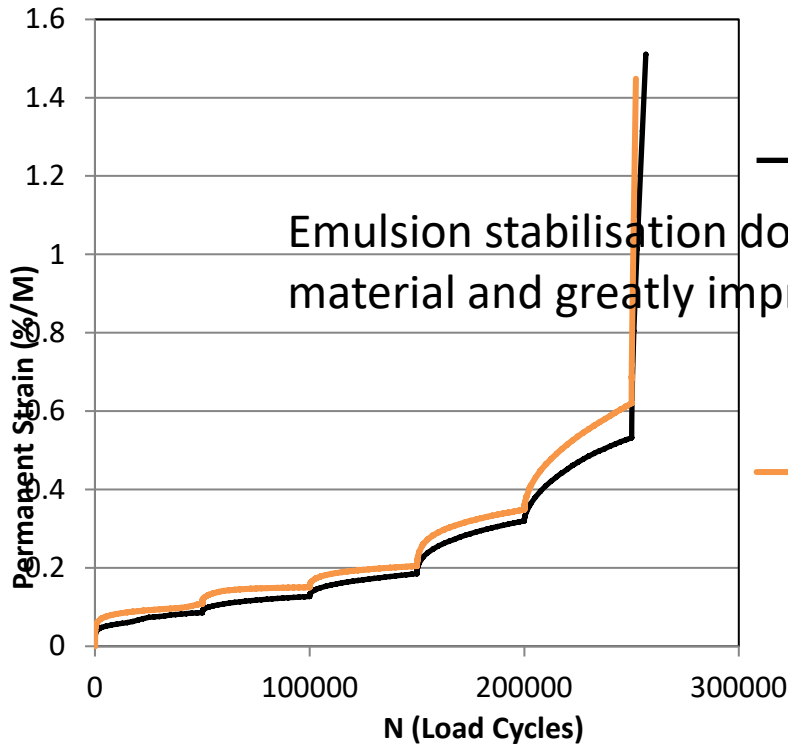
## Dry Testing

Emulsion stabilisation does not reduce the dry strength of the material and greatly improves the wet performance
