Cement Modification of Low

Grade Aggregates for Urban

Maintenance

Paul Howard and Phil Pawsey

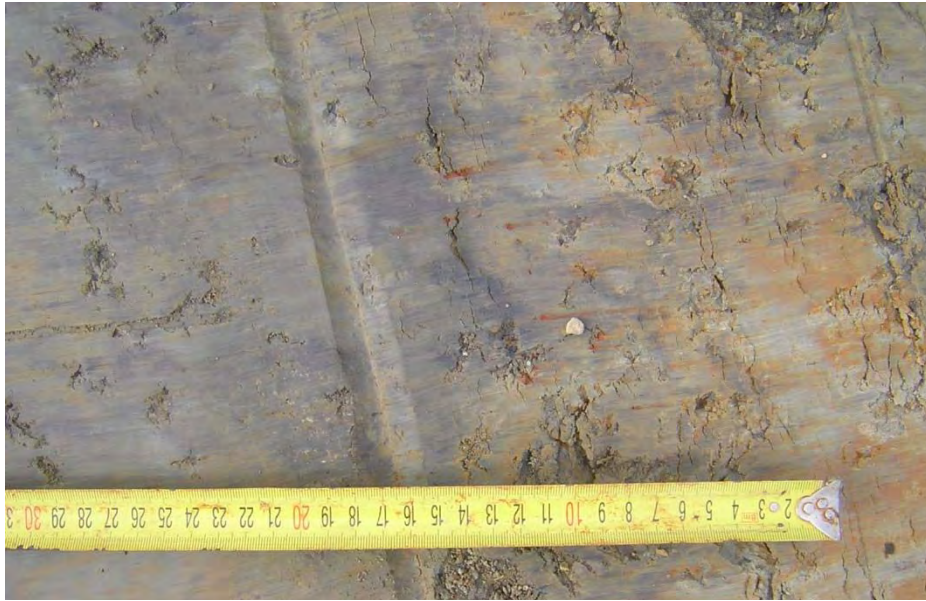
Common local subgrade –
blue and yellow pug – very
unstable

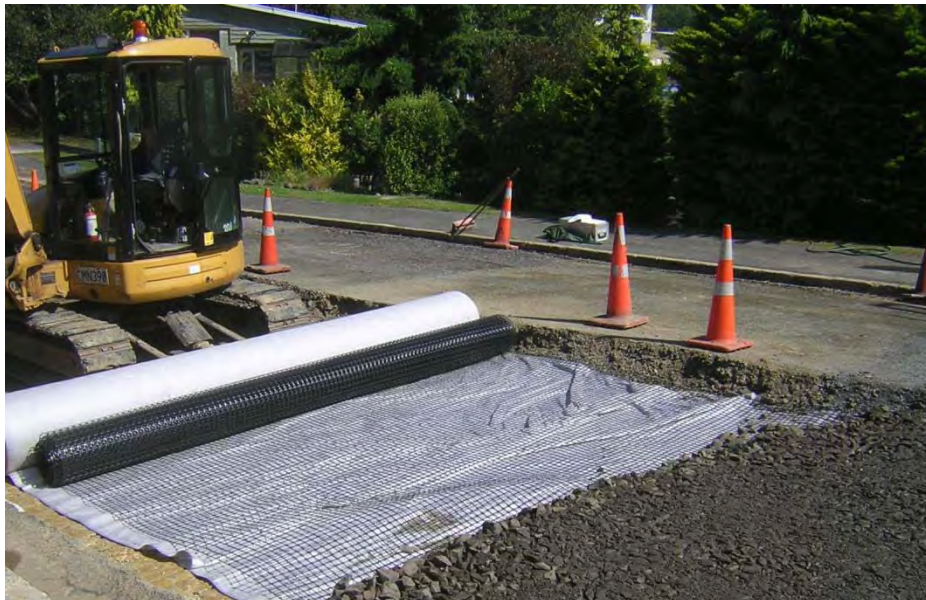
Site excavated with fabric,
grid and AP65 being laid.

- Aggregate selection – M4 AP40 selected as control, a standard AP40 and second grade AP40 (B40).
- Stockpiled aggregates in yard and treated with 2% cement.
- Weathered for 7 days while turning regularly
- Site excavated to 300mm depth, fabric and grid placed, 150mm layer AP65 across entire excavation
- Site divided into sections (half road) and the control, treated and untreated samples placed.
- Compacted in lifts with Bomag BPR55/65 (~480kg) at approximate OMC.
- Surface finished and sealed

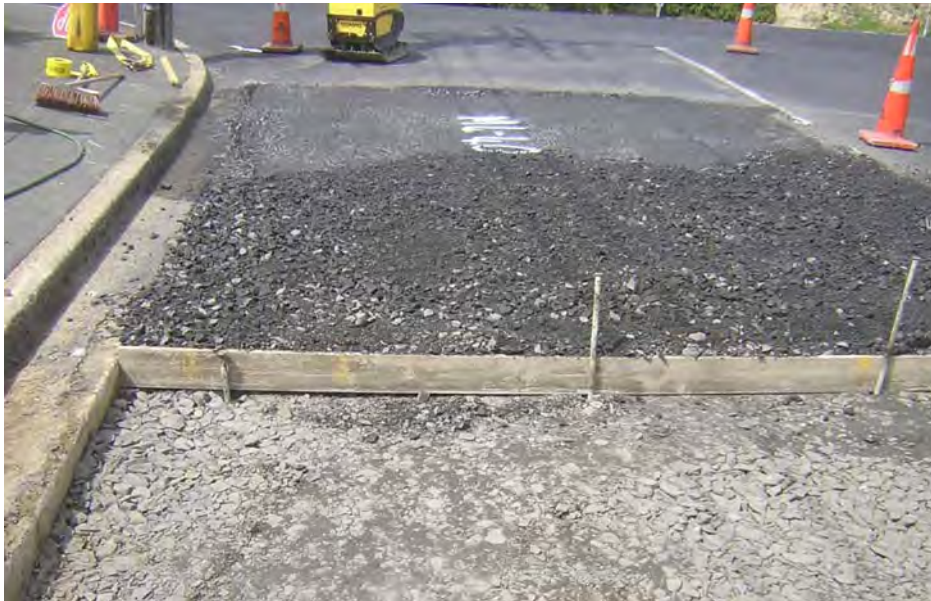
Test sections separated by timber edging

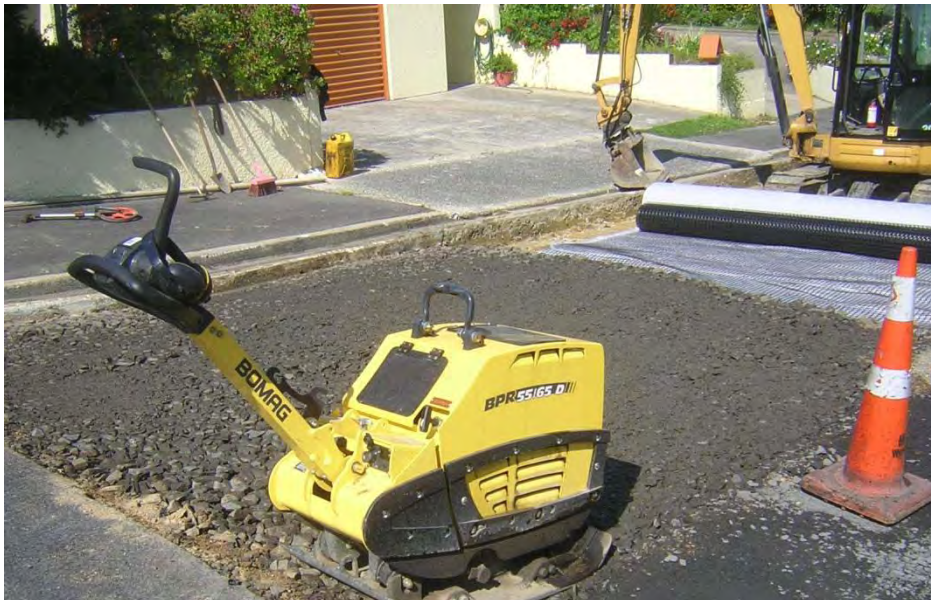
Compacted with 480kg reversible plate

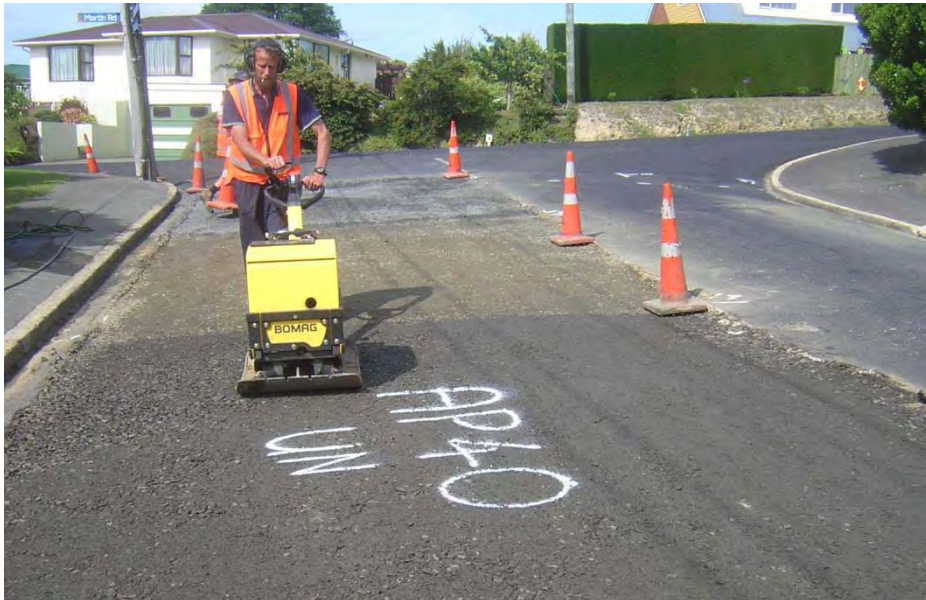
Compacting patch as a single excavation to ensure uniformity

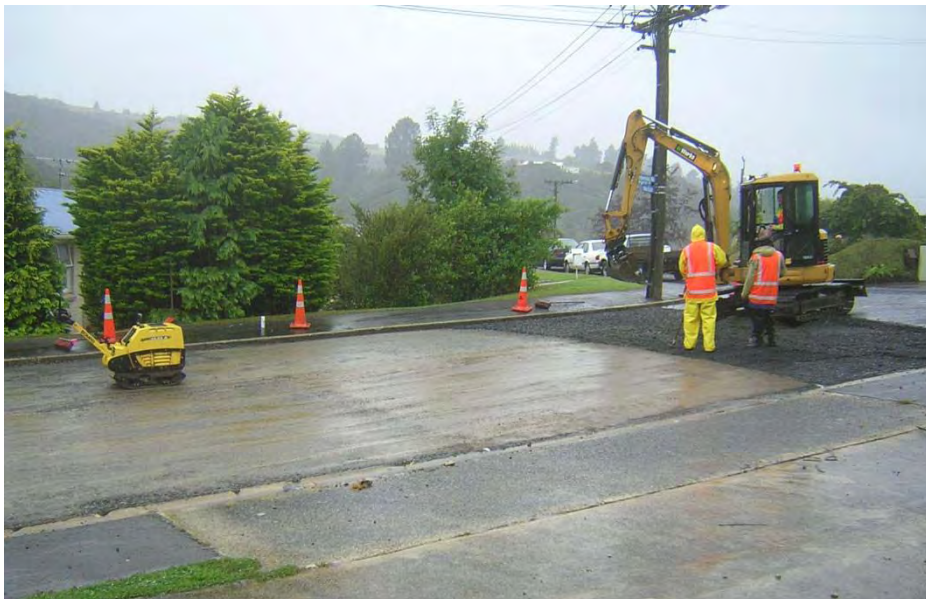
Final wetting and rolling, attempting to reactivate cement

- The final surface was visually good. Ironically there was a problem getting a tight surface on the M4 AP40.
- Compaction of all test samples achieved easily to mosaic surface.
- Comments that the workability of lower quality materials was easier.
- Some visual indication that cement was reactivating.
