Glacier Roads Seal Extensions

Can a 'Win Win' be achieved between conflicting philosophies of engineering & safety standards and those of a National Park

Tom Hopkins (DOC) and Jim McNeill (GHD)

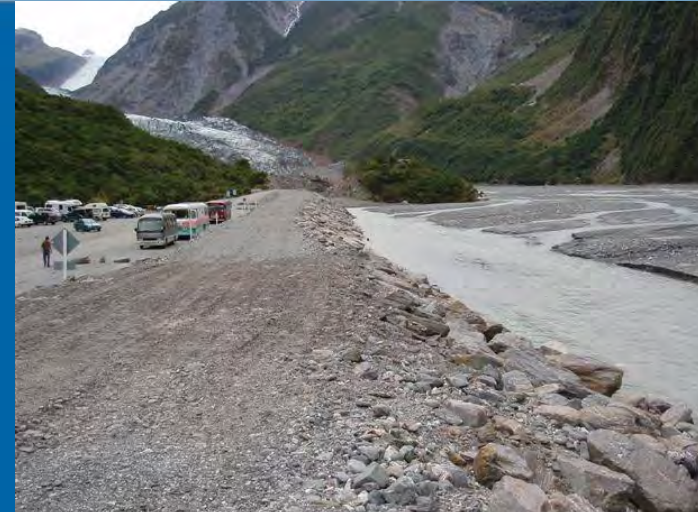
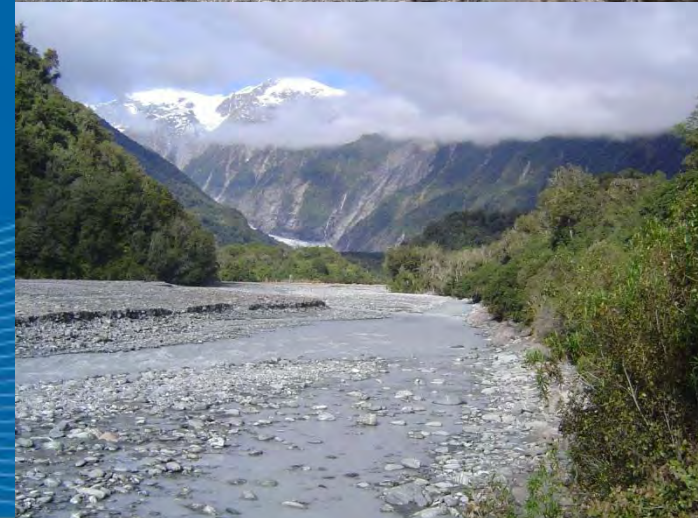
Issues

- Growth in visitor numbers (330,000 Franz & 184,00 Fox) – ADDT's 1040 and 860 in 2004
- Tourist traffic: campervans, buses and pedestrians and cyclist (safety issues)
- Low level of service for visitors
- Dust nuisance
- Carriageway width below standard & tight horizontal curves

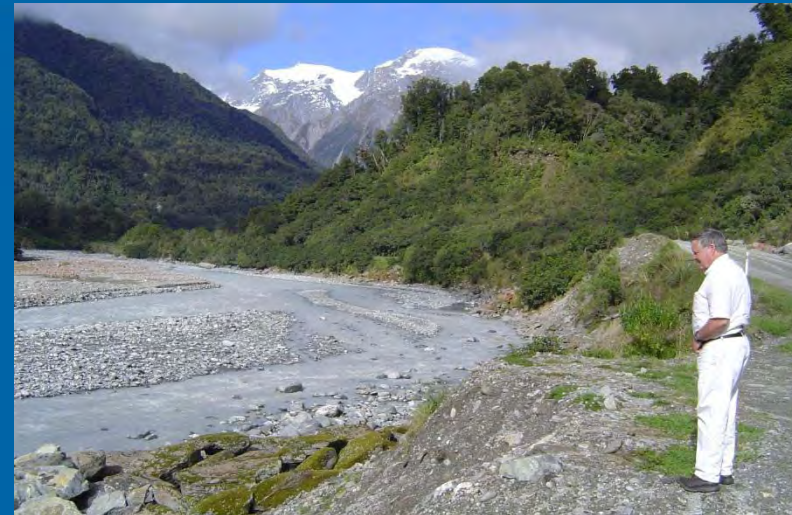
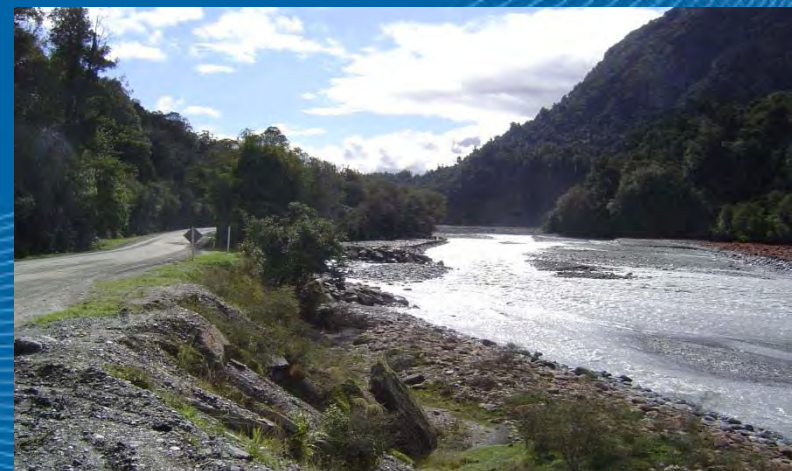
Site Constraints

- Active rivers and streams subject to intense rainfall and flash floods
- Active landslides
- Extreme topography – regular & random rockfalls
- Land Status
