# Managing Future Demands

## Michael Kemsley- GHD Wilson Cutting Road Reinstatement - Not Just a Low Volume Road

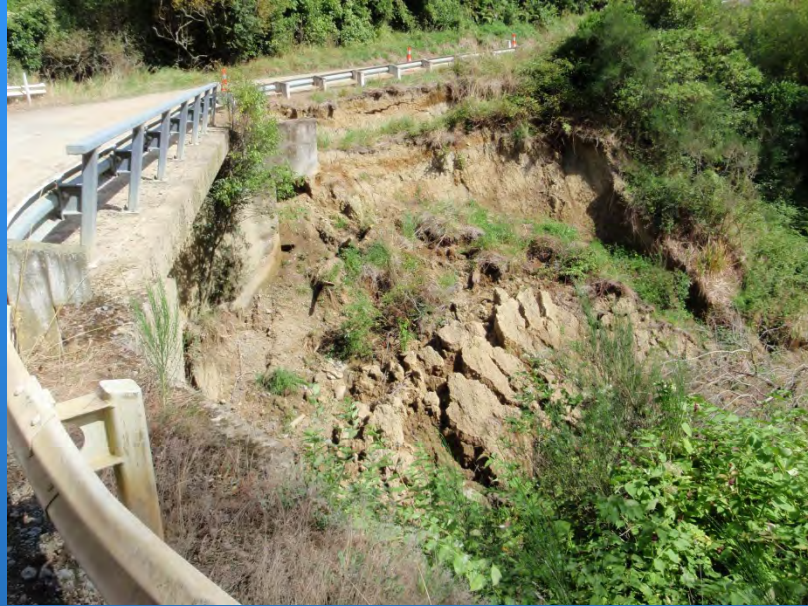
Initial slip:

- Wilson Cutting Road carries 29 vpd, (latest estimate) @ Northern road end,
- Generally single lane access with tight geometry
- A routine bridge inspection undertaken in March 2014 discovered a large undercut approximately 15m long, extending from bridge abutment, its approximately 6m to the stream
- Client notified, minor remedial works, with road remaining open
- Drop out quickly worsened resulting in road closure

Road Remained open

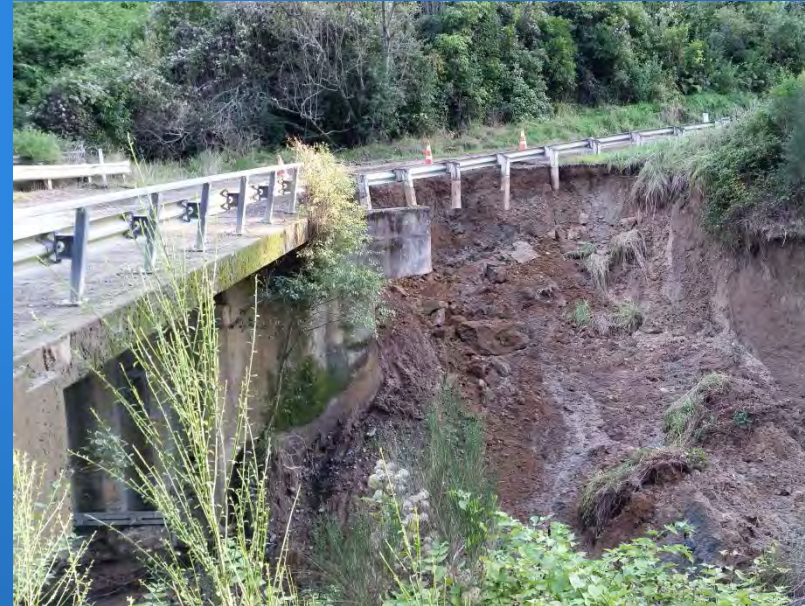
Further failures:

Road closed

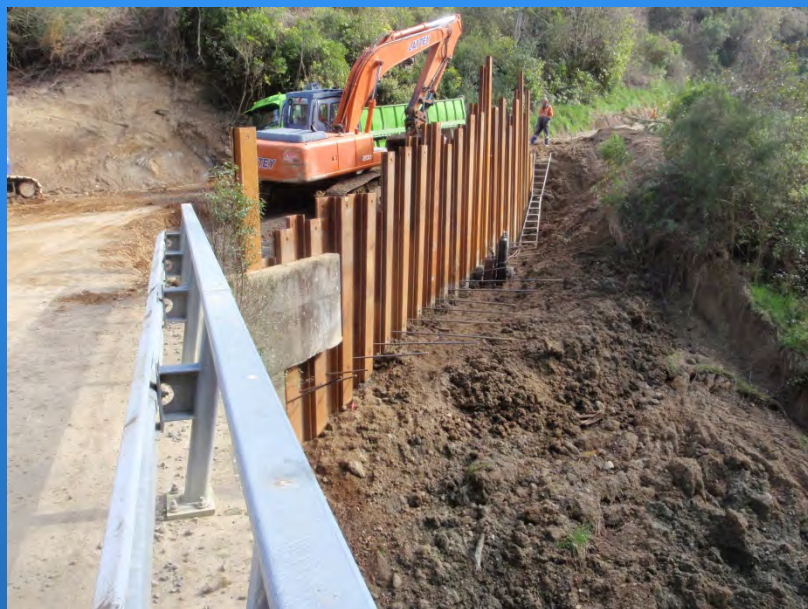
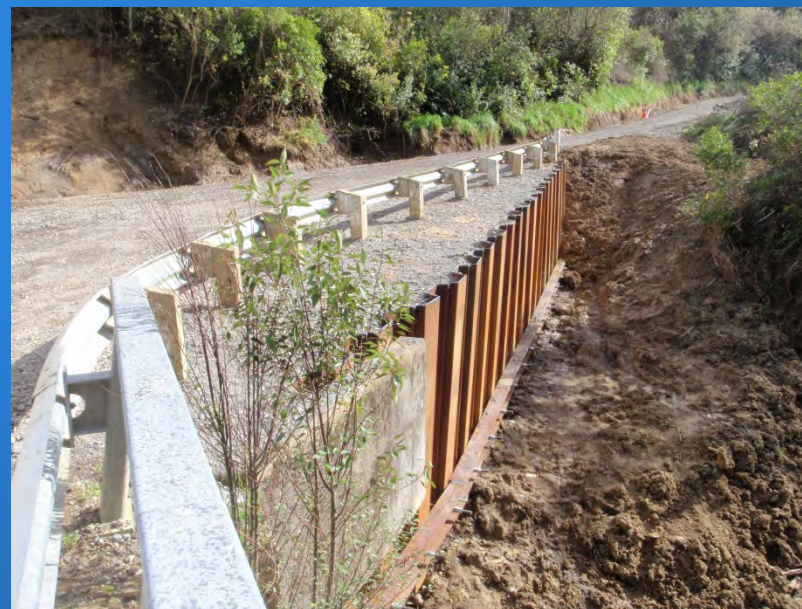
- The end result

- The results:
- Established fundability with a budget of \$232,000.
  - Delays \$179,000 (40yr life TTC and VOC)
  - Loss of land value \$100,000
  - Increased costs for emergency responses \$83,000
- Estimated costs of approximately \$235,000.
  - Column drains on upslope side
  - Mechanically anchored sheet pile wall
  - Ongoing monitoring for additional toe scour
    - design relies on toe support, additional row of anchors installed if required in future.
