Use of a Driver Feedback Sign In Reducing drivers' speed through roadworks

Purpose

This research paper investigates the impact of a Driver Feedback Speed Display (DFSD) sign on drivers' speed through road works.

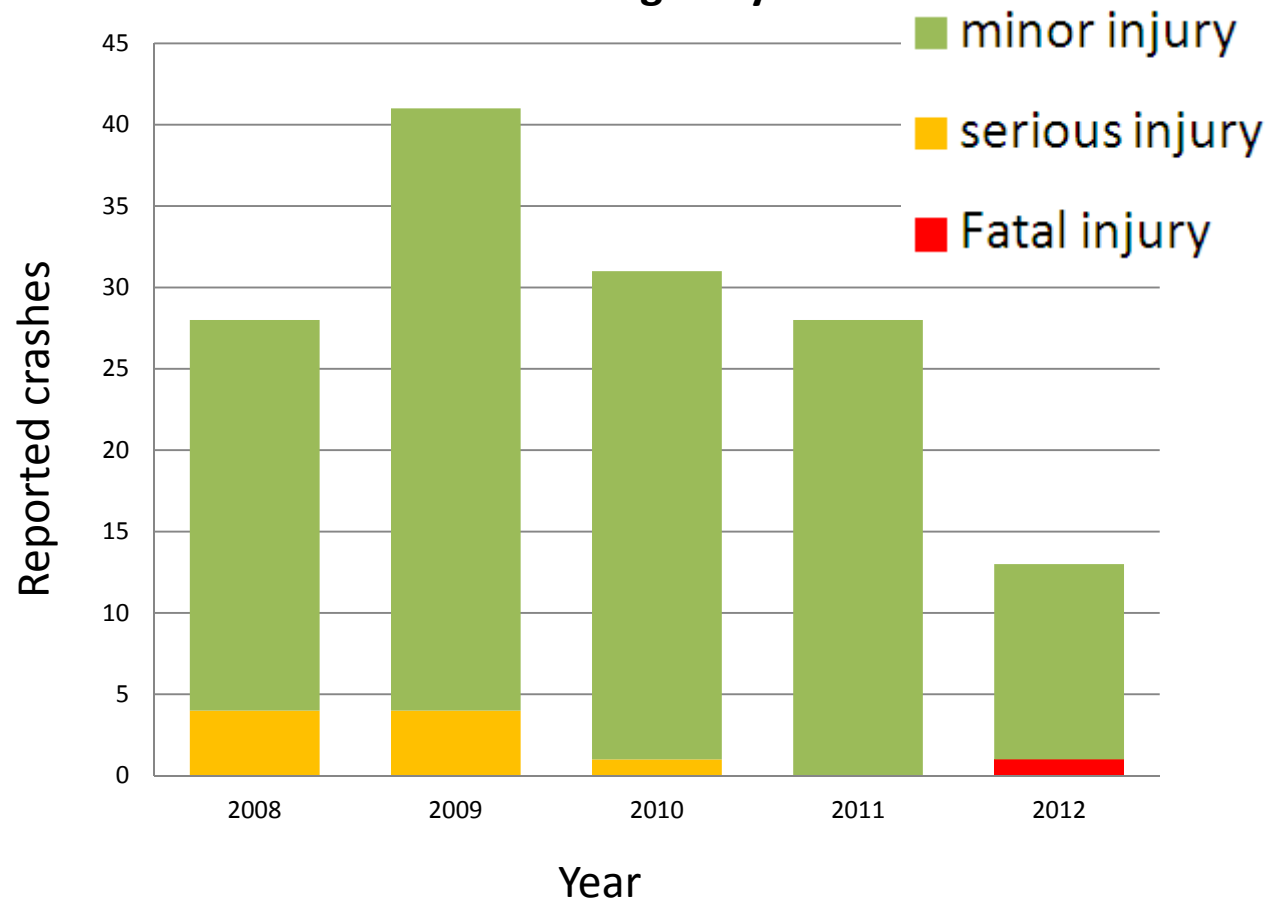
Reported Injury Crashes due to speeding drivers within Temporary Speed Limit - State Highways

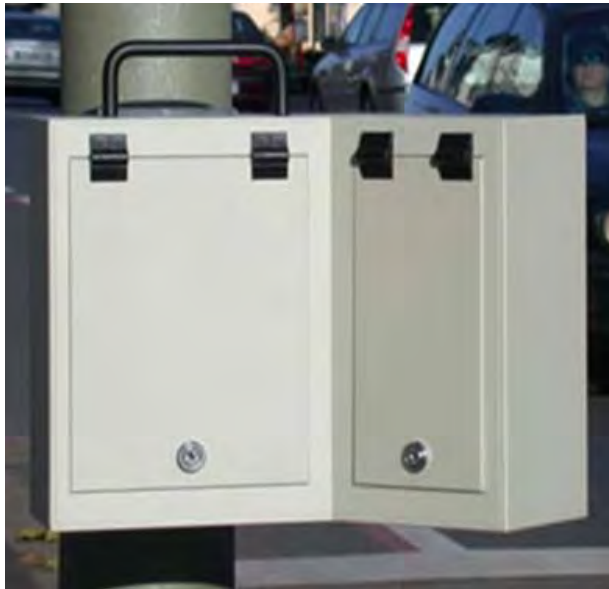
A radar unit

Product Name: Viacount II

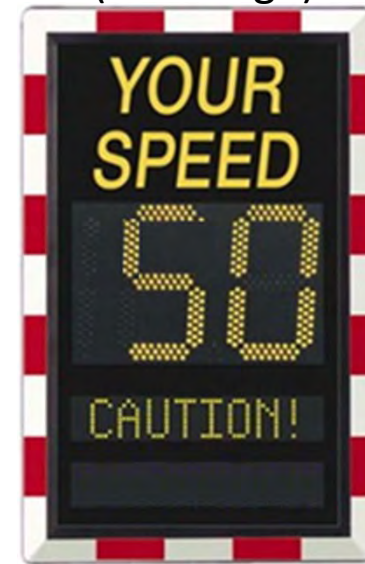
Driver Feedback Speed Display Sign
(DFSD Sign)

Product Name: Vaisis

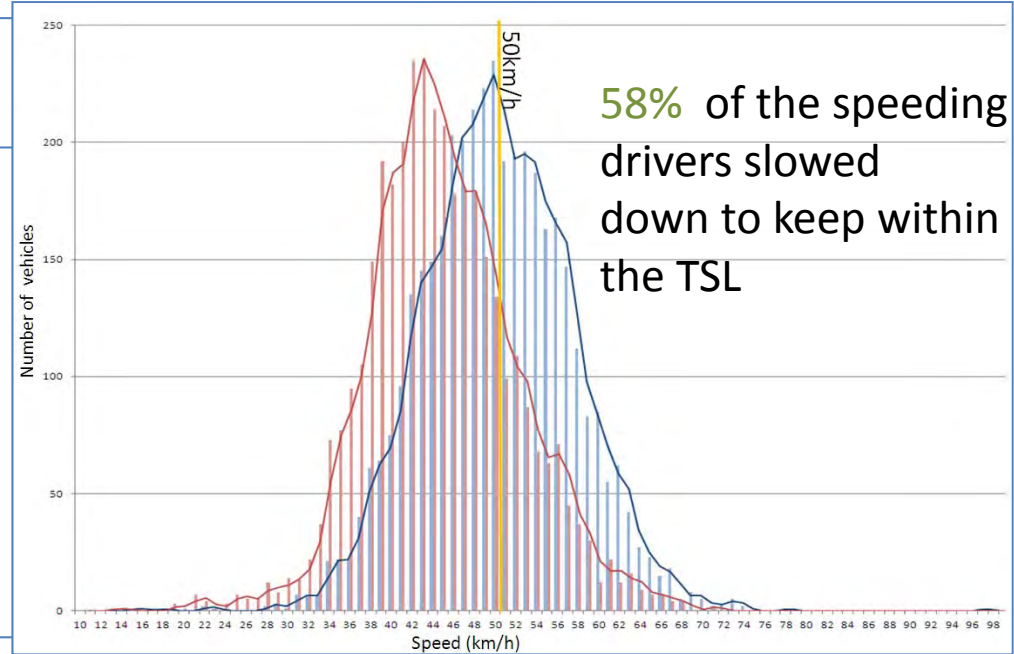
Site 2: Ngauranga on-ramp – Method 1

Temporary Speed Limit = 50km/h

Before 18/04/2013	After 22/04/2013
Speeding vehicles	46%	19%

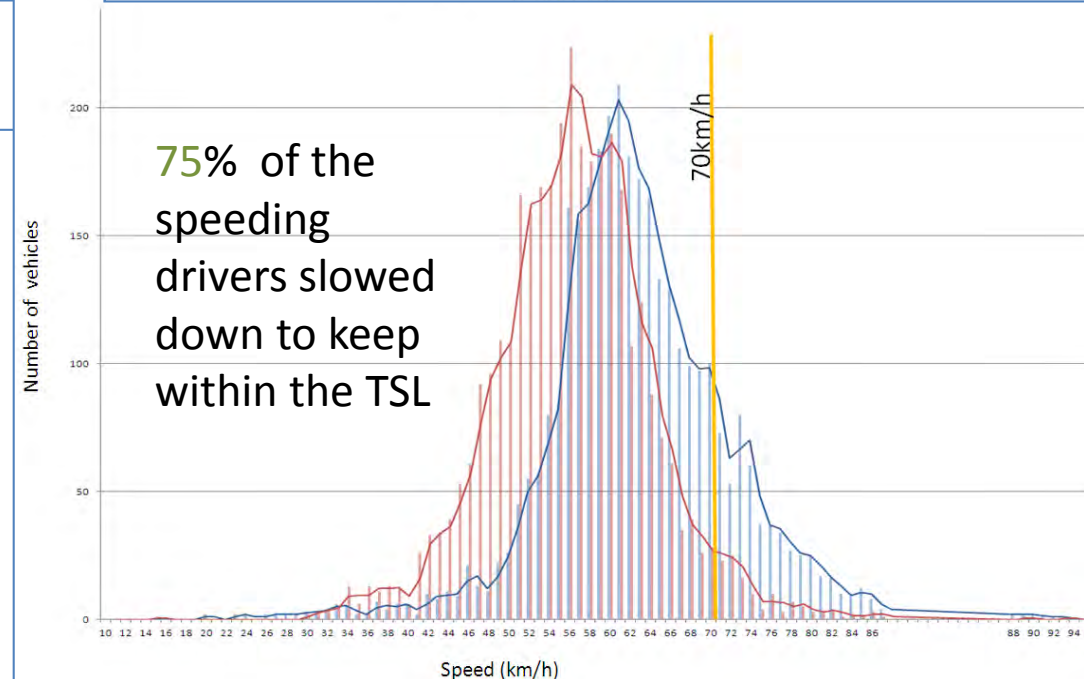
Site 3: Dowse Drive – Method 1

Temporary Speed Limit = 70km/h

Before 30/04/2013	After 1/05/2013
Speeding vehicles	16%	4%

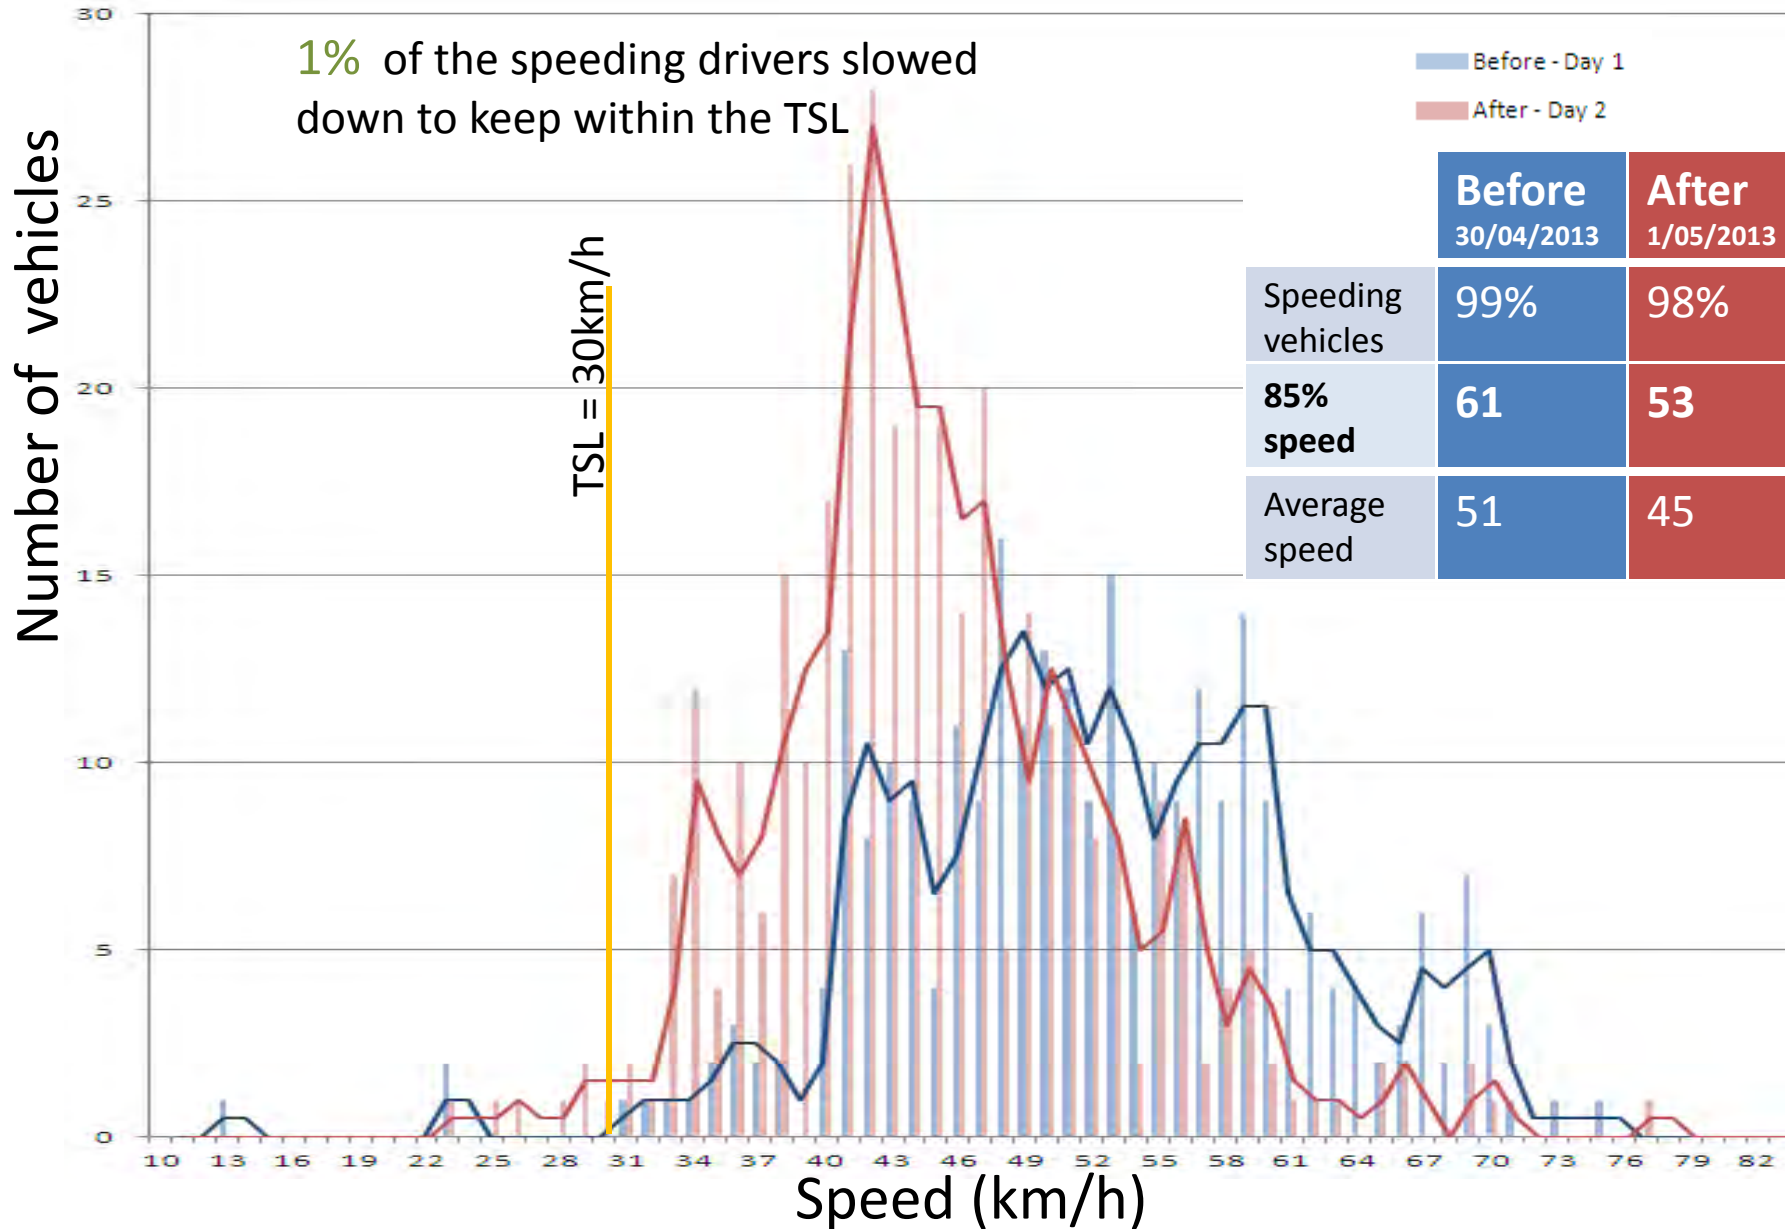
Site 4: SH2 / Willow Park Drive - Method 1

Temporary Speed Limit = 30km/h

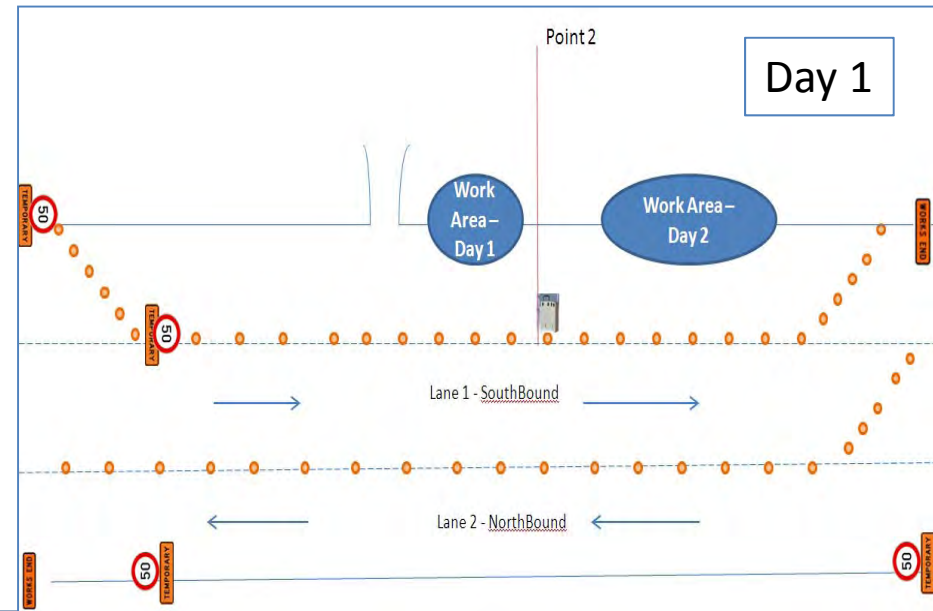
Analysis method 3

Four scenarios are listed below:

1. Day 1, SB lane without feedback sign
2. Day 2, SB lane with feedback sign
3. Day 1, NB lane without feedback sign
4. Day 2, NB lane without feedback sign

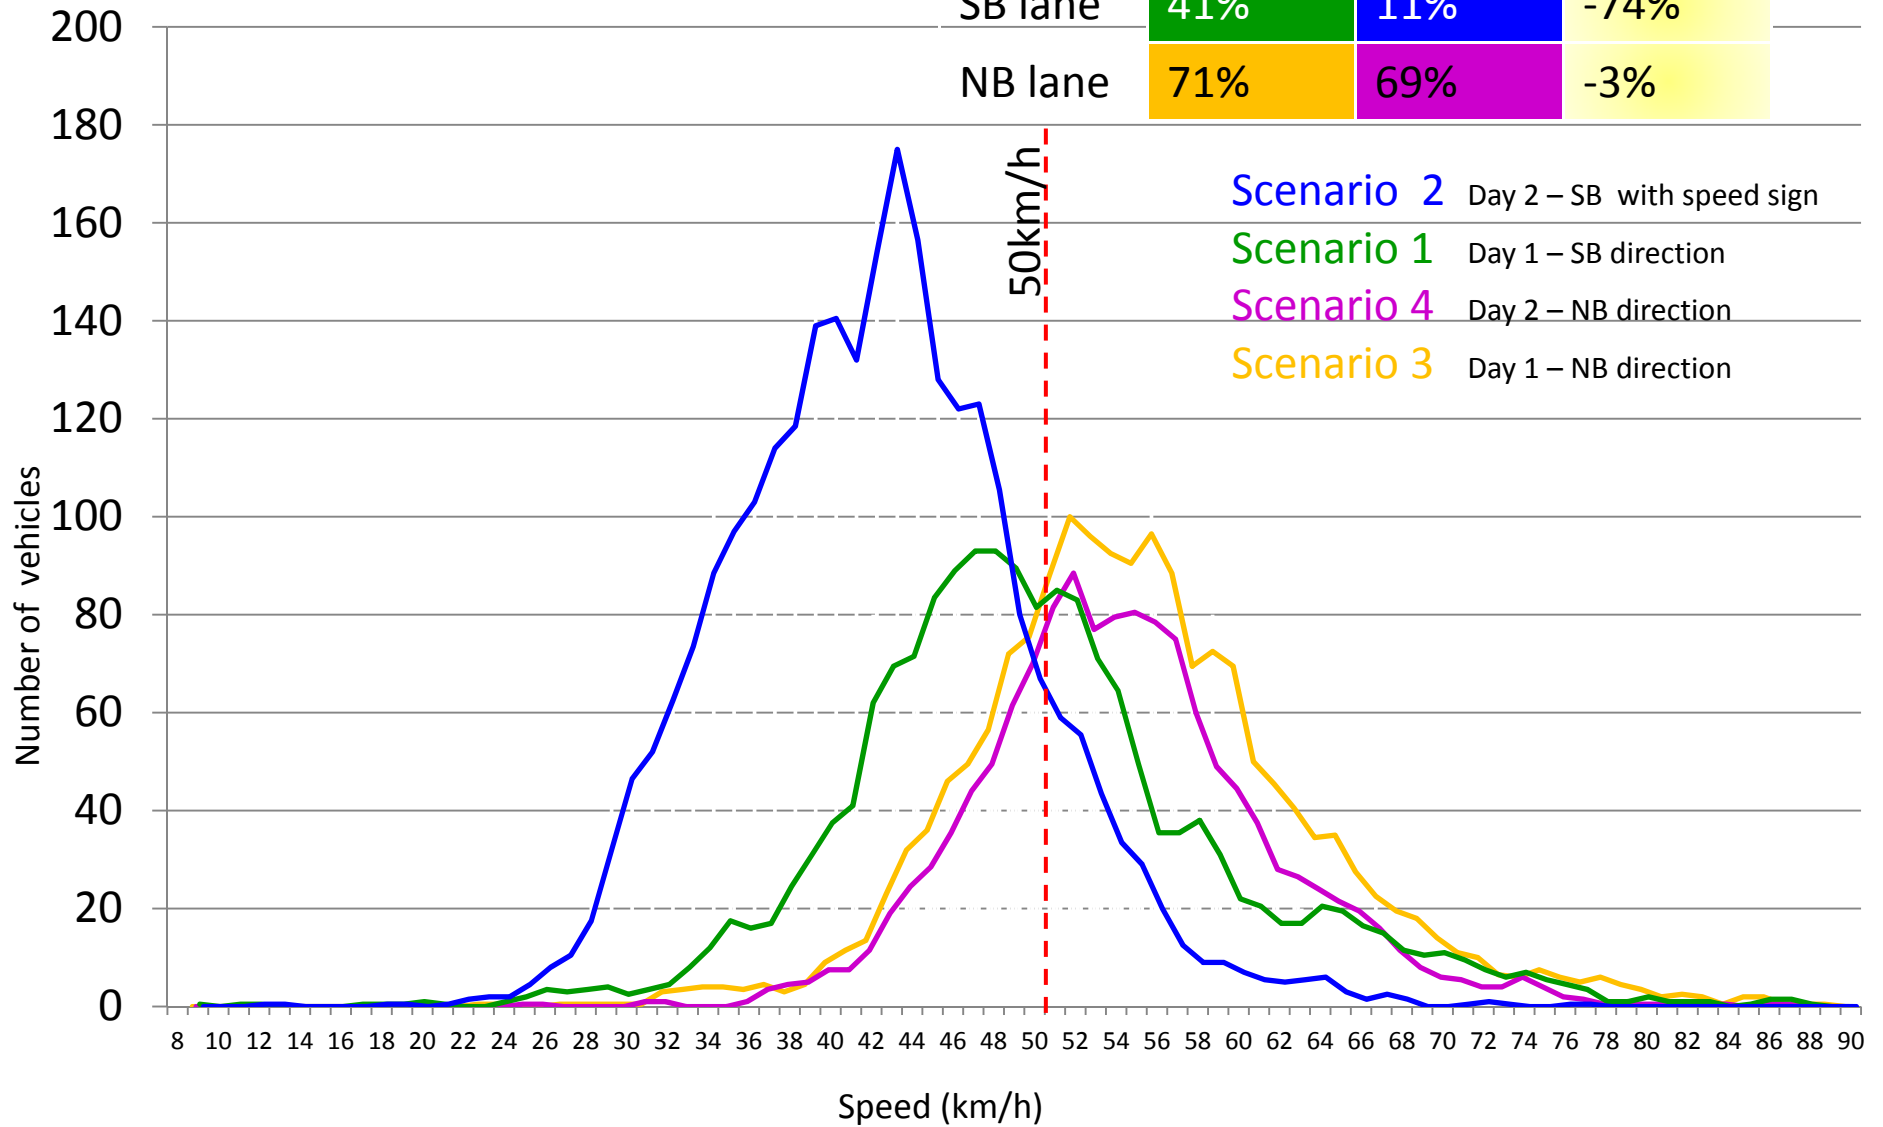
Site 1: Te Horo – Method 3
 Temporary Speed Limit (TSL) = 50km/h

Speeding vehicles (%)	Day 1 11/04/2013	Day 2 12/04/2013	% drop on Day 2
SB lane	41%	11%	-74%
NB lane	71%	69%	-3%

Scenario 2 Day 2 – SB with speed sign
Scenario 1 Day 1 – SB direction
Scenario 4 Day 2 – NB direction
Scenario 3 Day 1 – NB direction
