DIAL Runway 21-03

Runway 21-03

- 1900m long, 46m wide, Code 4C runway
- Asphalt surfacing
- Last overlaid in 2001
- Southern 200m extension constructed 1993
no overlay since
- Maintenance cost accelerating by Dec 2011
annual inspection
- Cracksealing and mill and fills

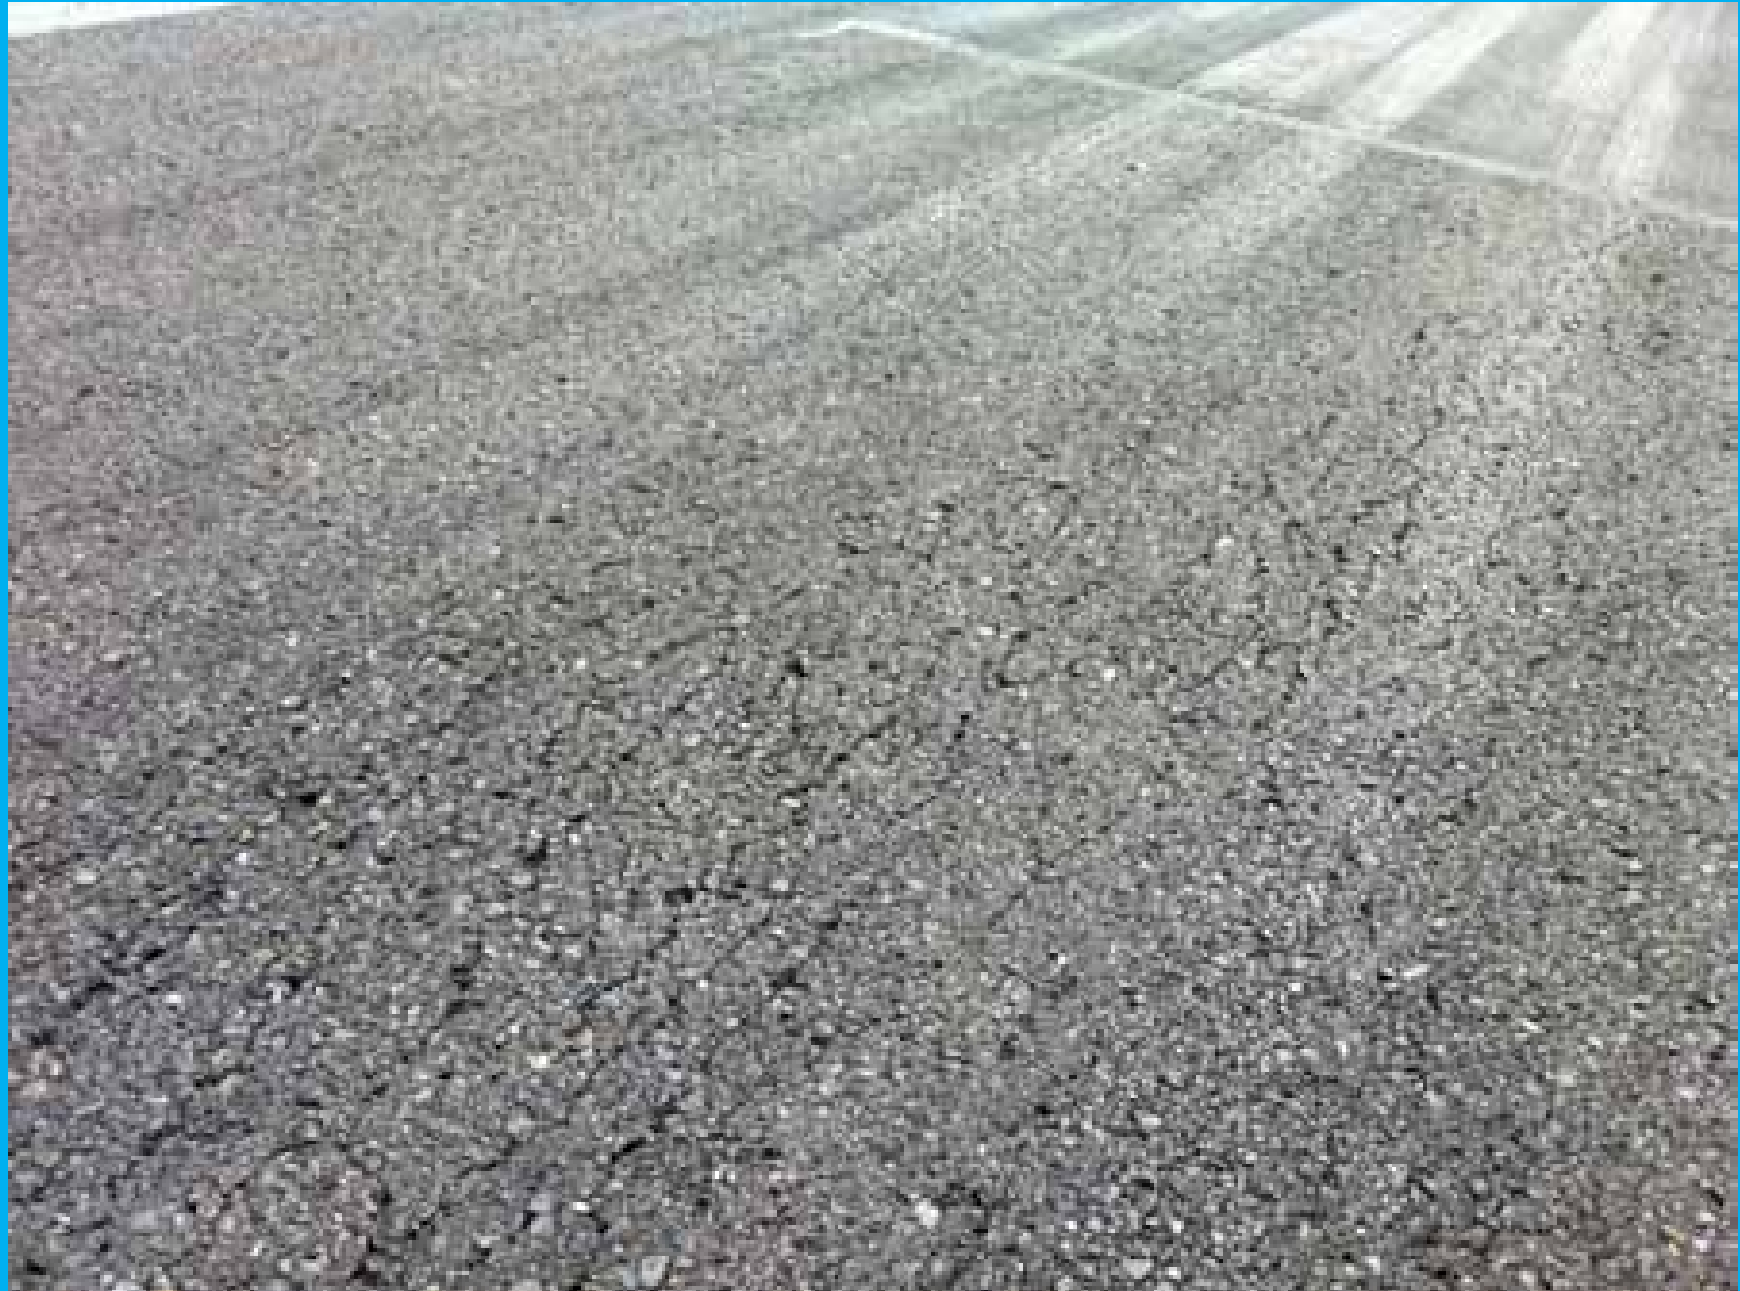
- Visual (annual December inspections)
 - Annual survey reveals cracking extending past recent patches
 - Marked increase in crack sealing
 - Asphalt joints opening up
 - Turning nodes in poor condition
 - Drainage at node 03 not effective
- Topo Survey (August 2012)
 - What shape have we got? <0.2% to 3.5% crossfall

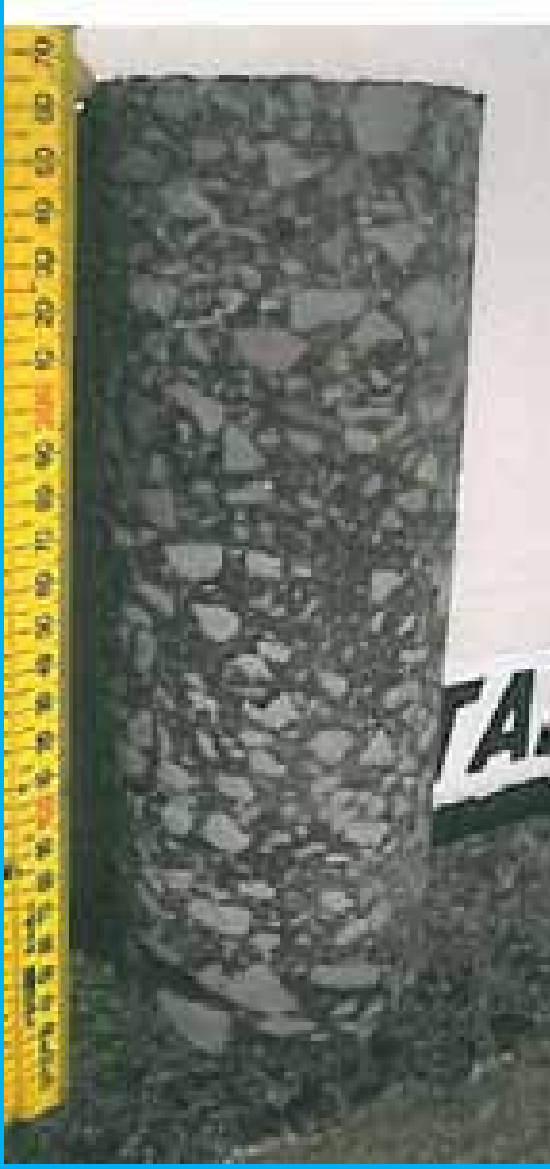
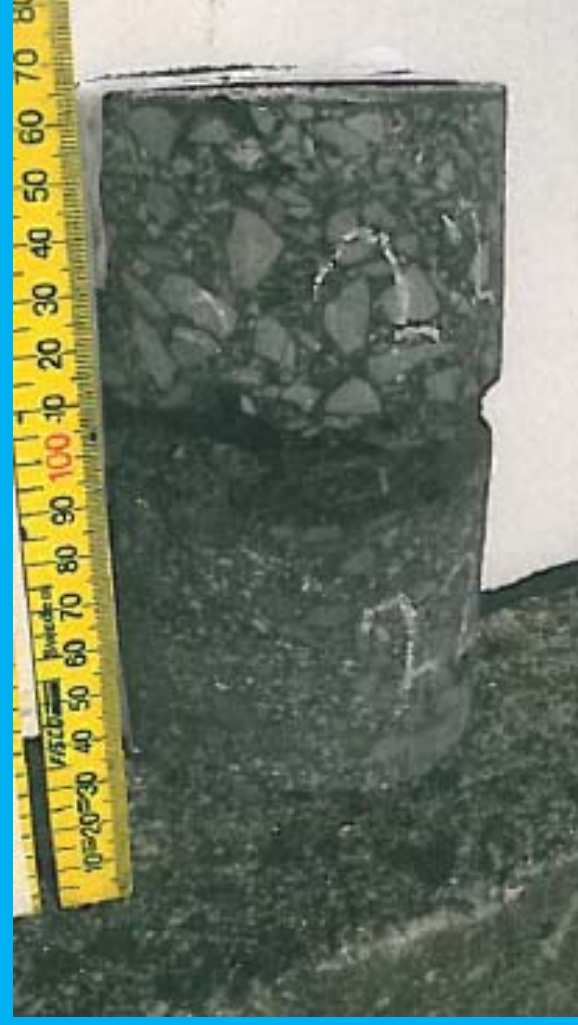
- Subsurface (Sept 2012)
 - FWD. Subgrade modulus appeared unrealistically high
 - Benkelmen Beam: 187 deflection points from 2005
 - GPR. Confirmed range of pavement materials
- Asphalt
 - 22 Cores (Sept 2012)
 - 17 Additional cores (January 2013)
 - Friction testing close to maintenance level
 - Defining repairs required before overlay
 - Water in asphalt? -Asphalt permeability

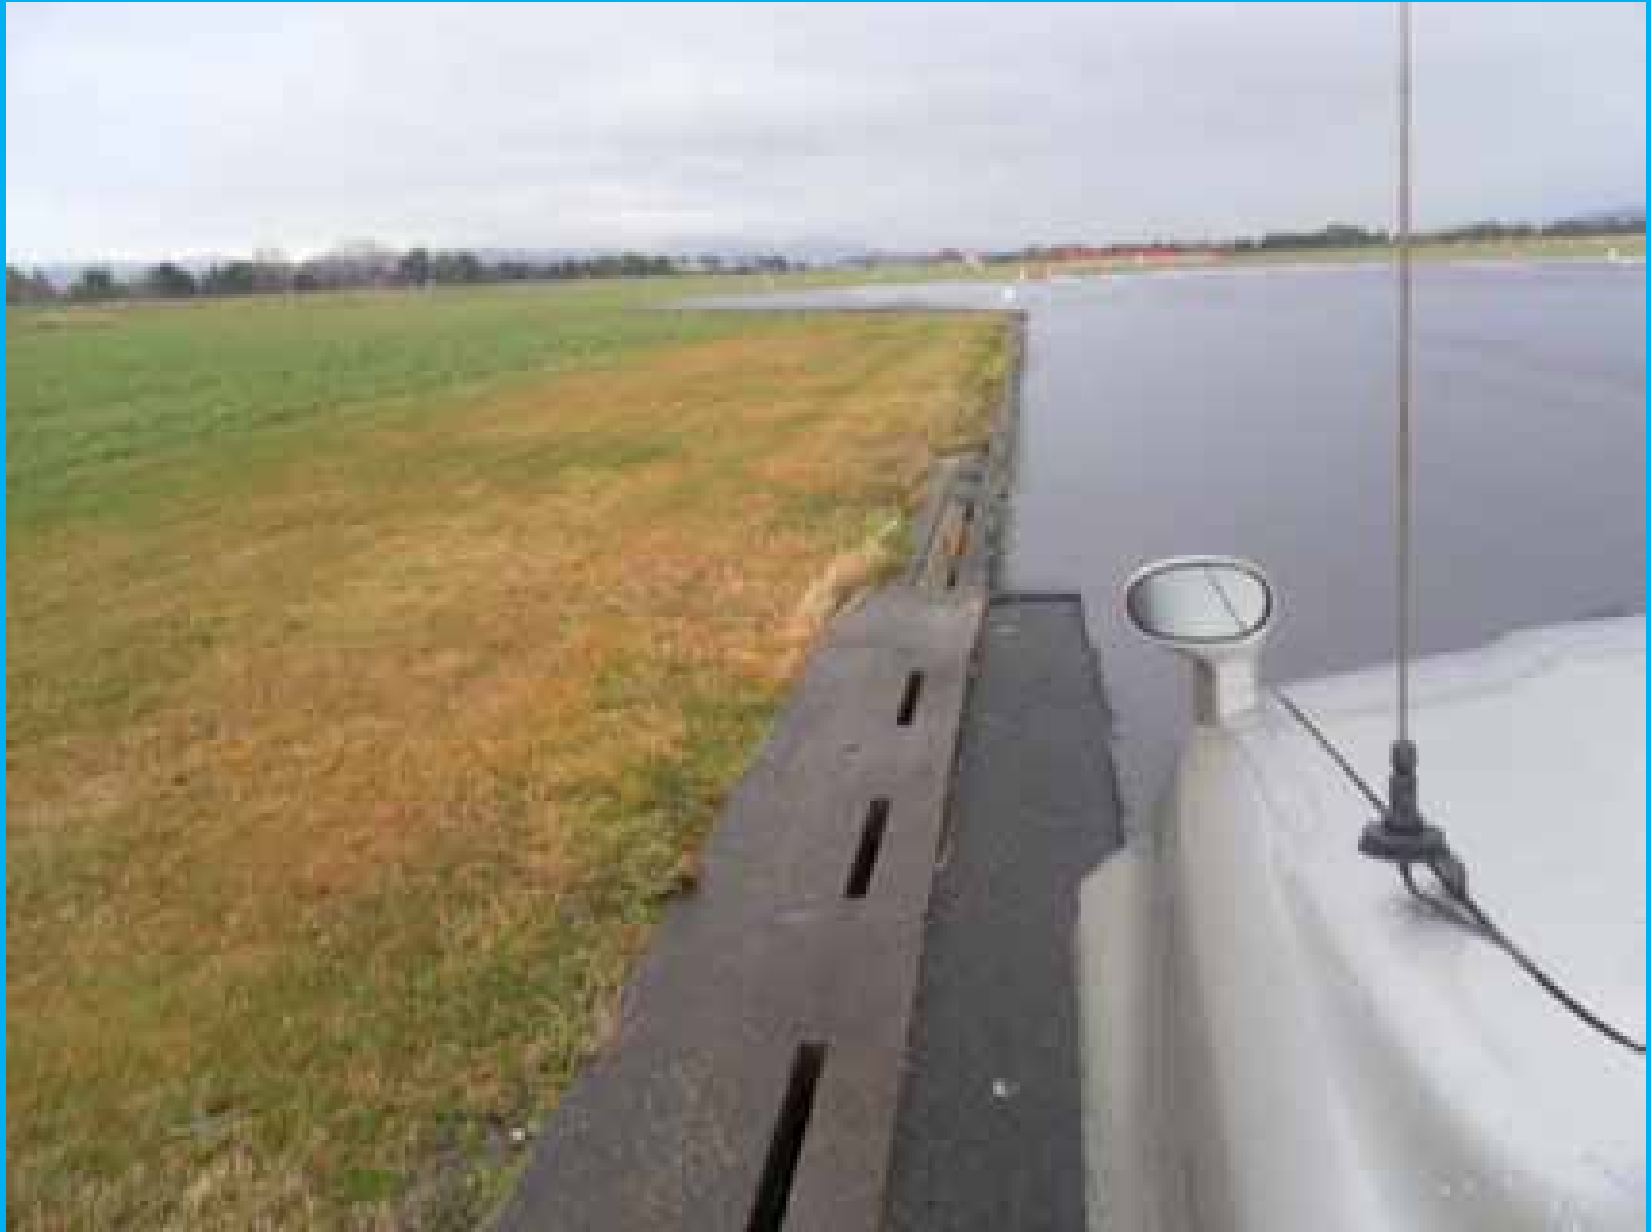
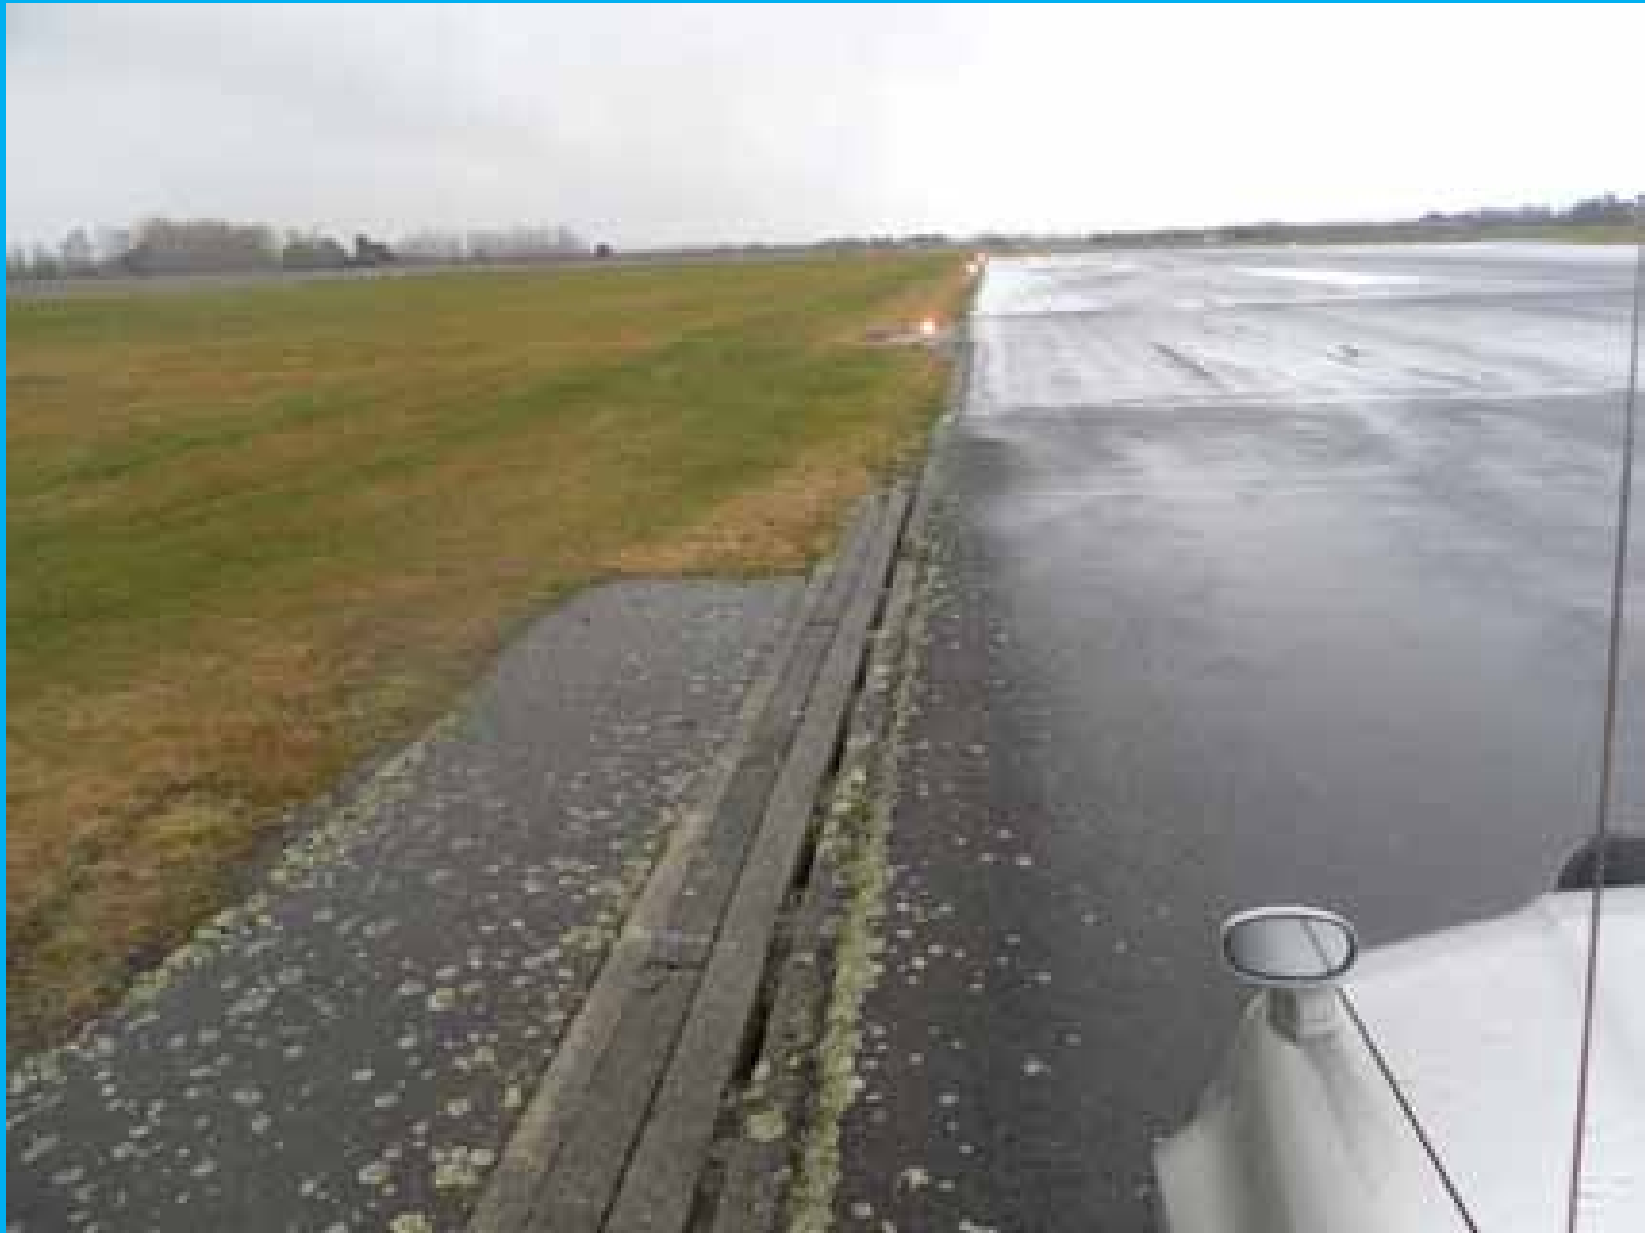
Design Constraints

- CAA 139-06 Governing document
 - 5% max end gradients
 - 25mm max edge drop
 - 1.5% 'ideal' crossfall
 - 30km Longitudinal radius, 1% slope, , limits on slope change
- Concrete slot drain and cable duct
- Extension has minimal crossfall but no edge drop
- Estimate of debonding extent
- BUDGET \$\$

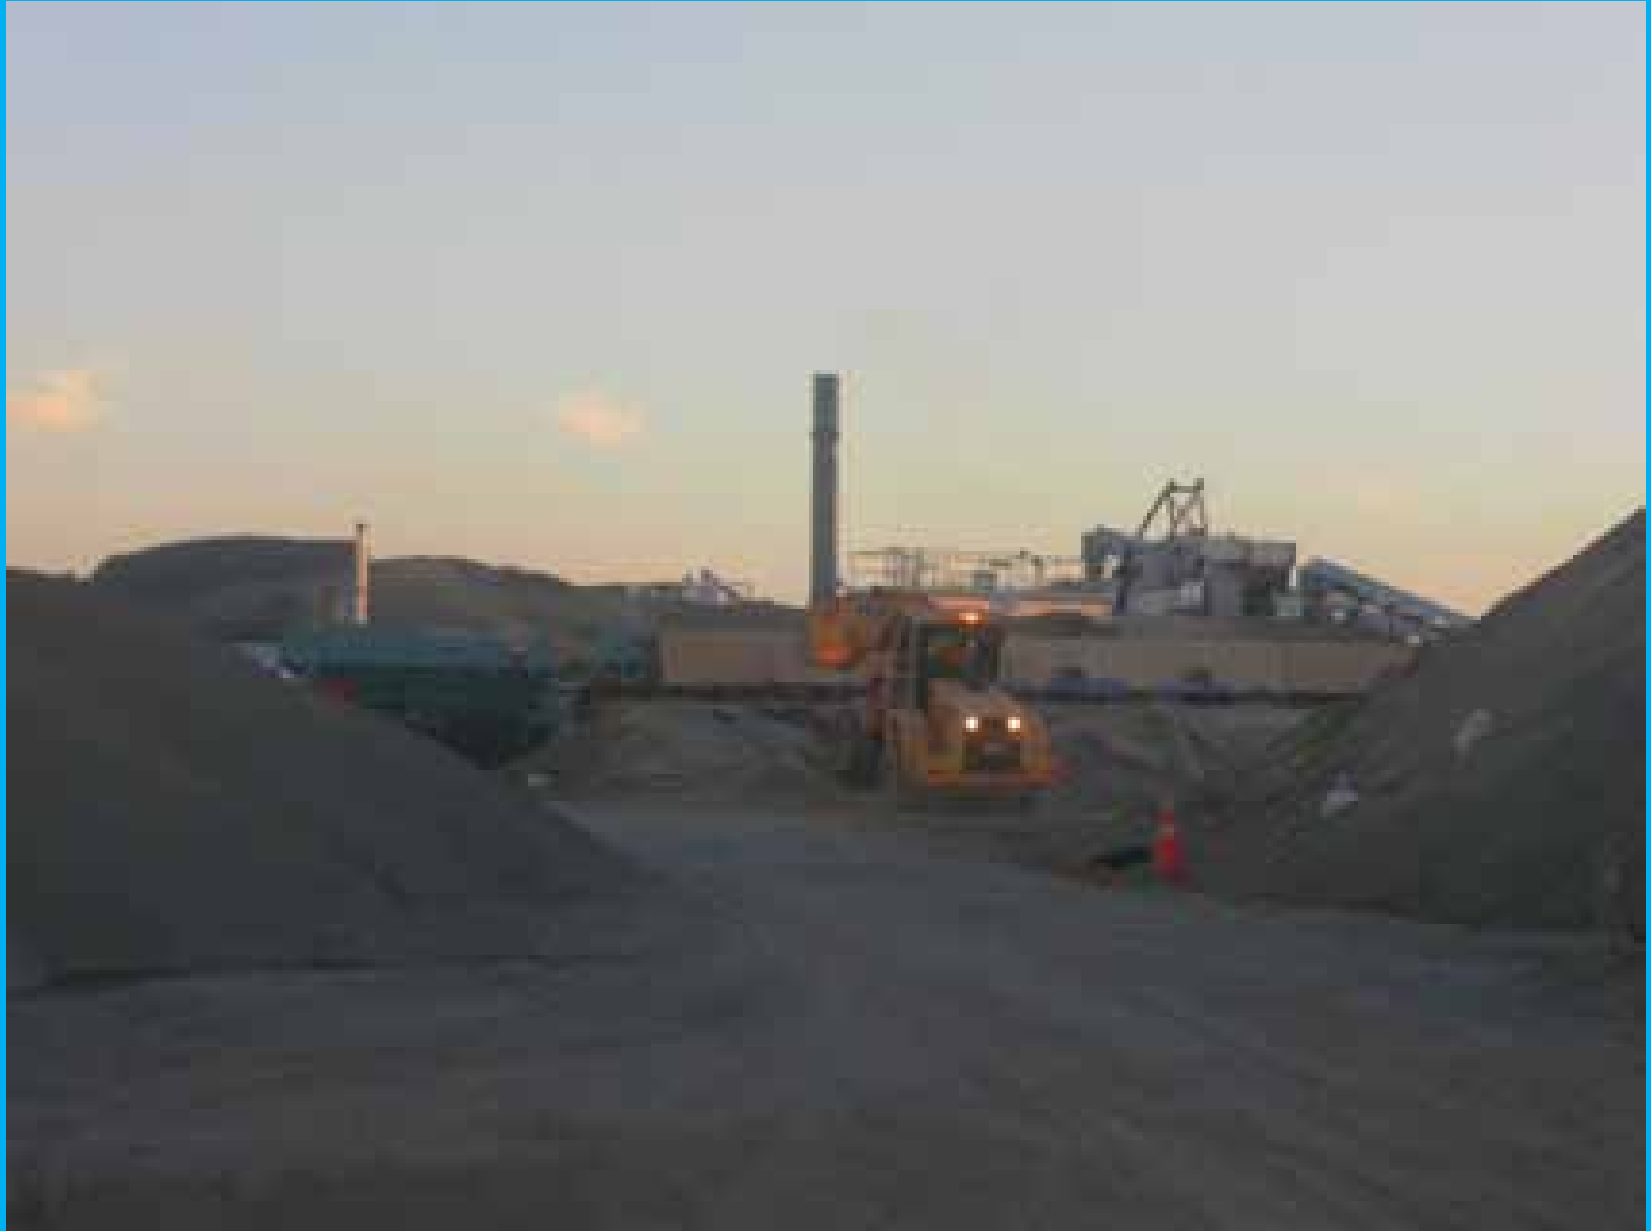
Field testing

- Core samples for air voids, RD and thickness
- British pendulum and sand circles each night
- Joint temperature

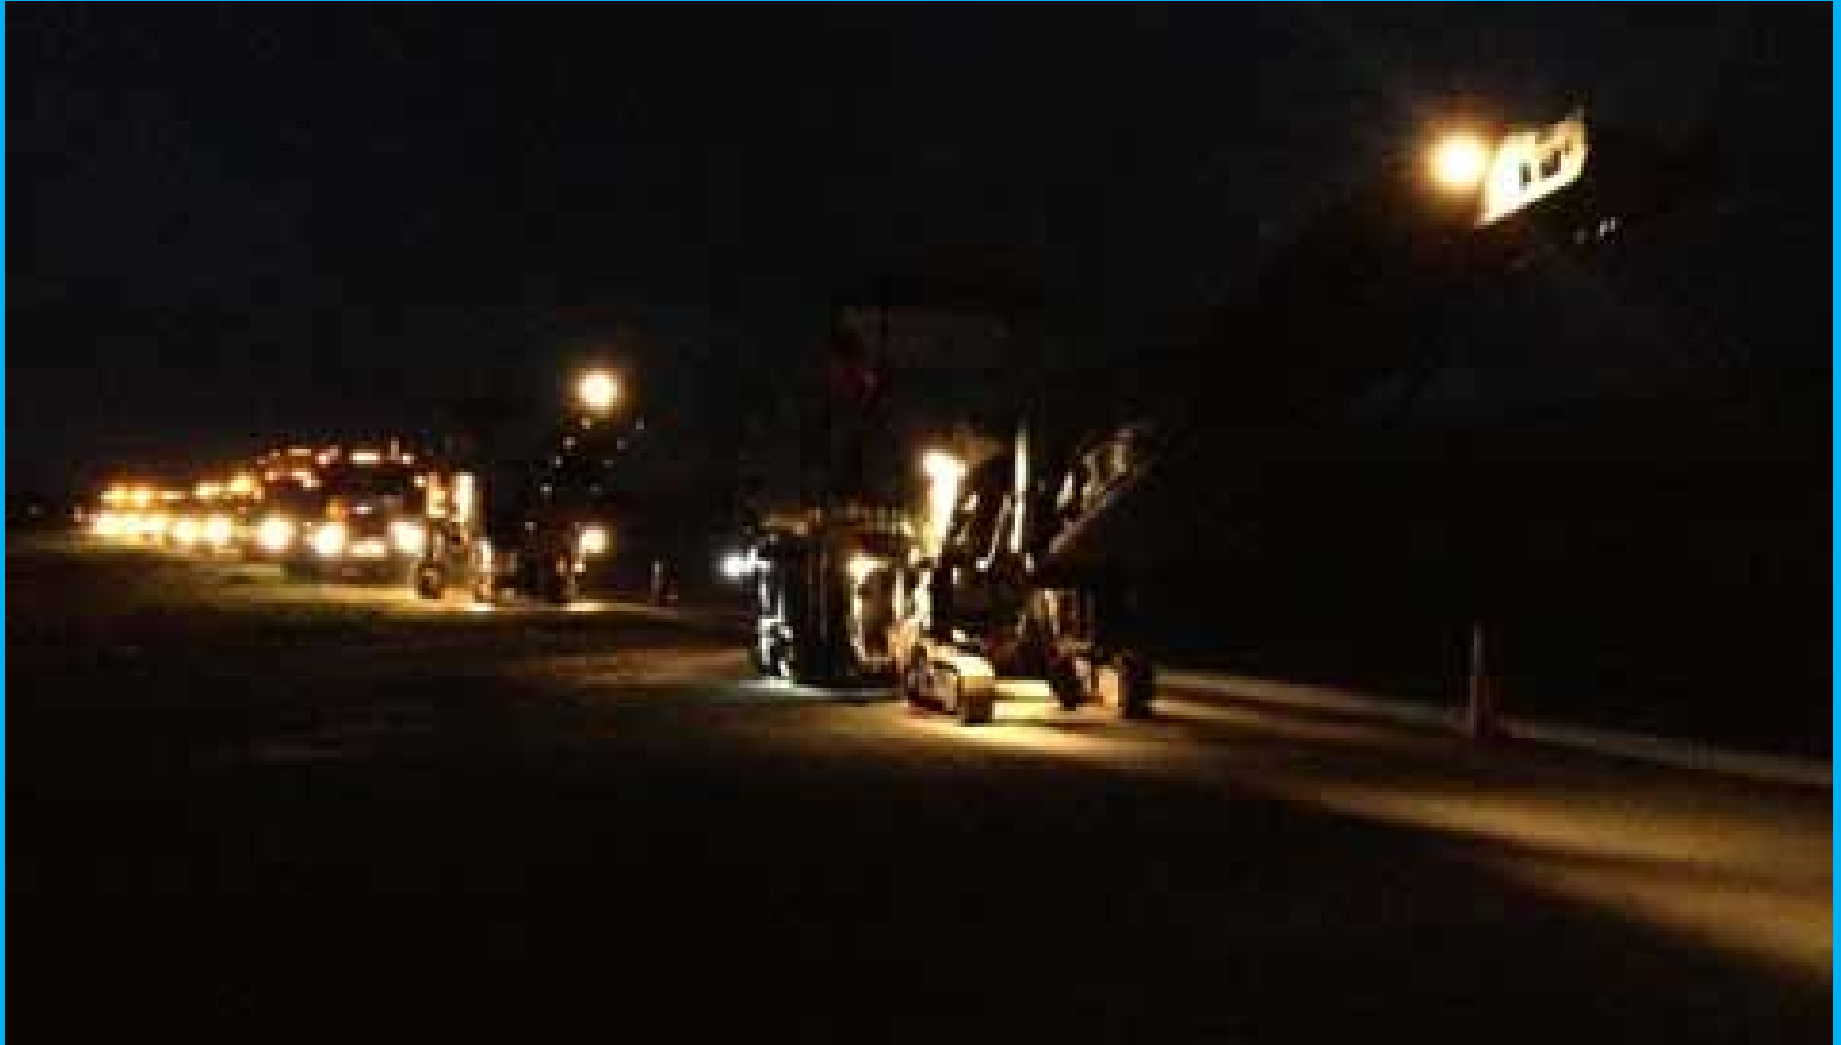
- Start on far side, Mill goes first. Up to 120m/night including milling out temporary ramps
- Debonding chased out and swept
- When mill reaches centreline membrane applied
- Asphalt applied to deeper milled areas
- Asphalt laid in 4.6m wide runs in echelon (including ramps) and rolled
- At centreline, decision to continue
- Pavement marking
- Emu parade
