DIAL Runway 21-03

Runway 21-03

- 1900m long, 46m wide, Code 4C runway
- Asphalt surfacing
- Last overlaid in 2001
- Southern 200m extension constructed 1993
no overlay since
- Maintenance cost accelerating by Dec 2011
annual inspection
- Cracksealing and mill and fills

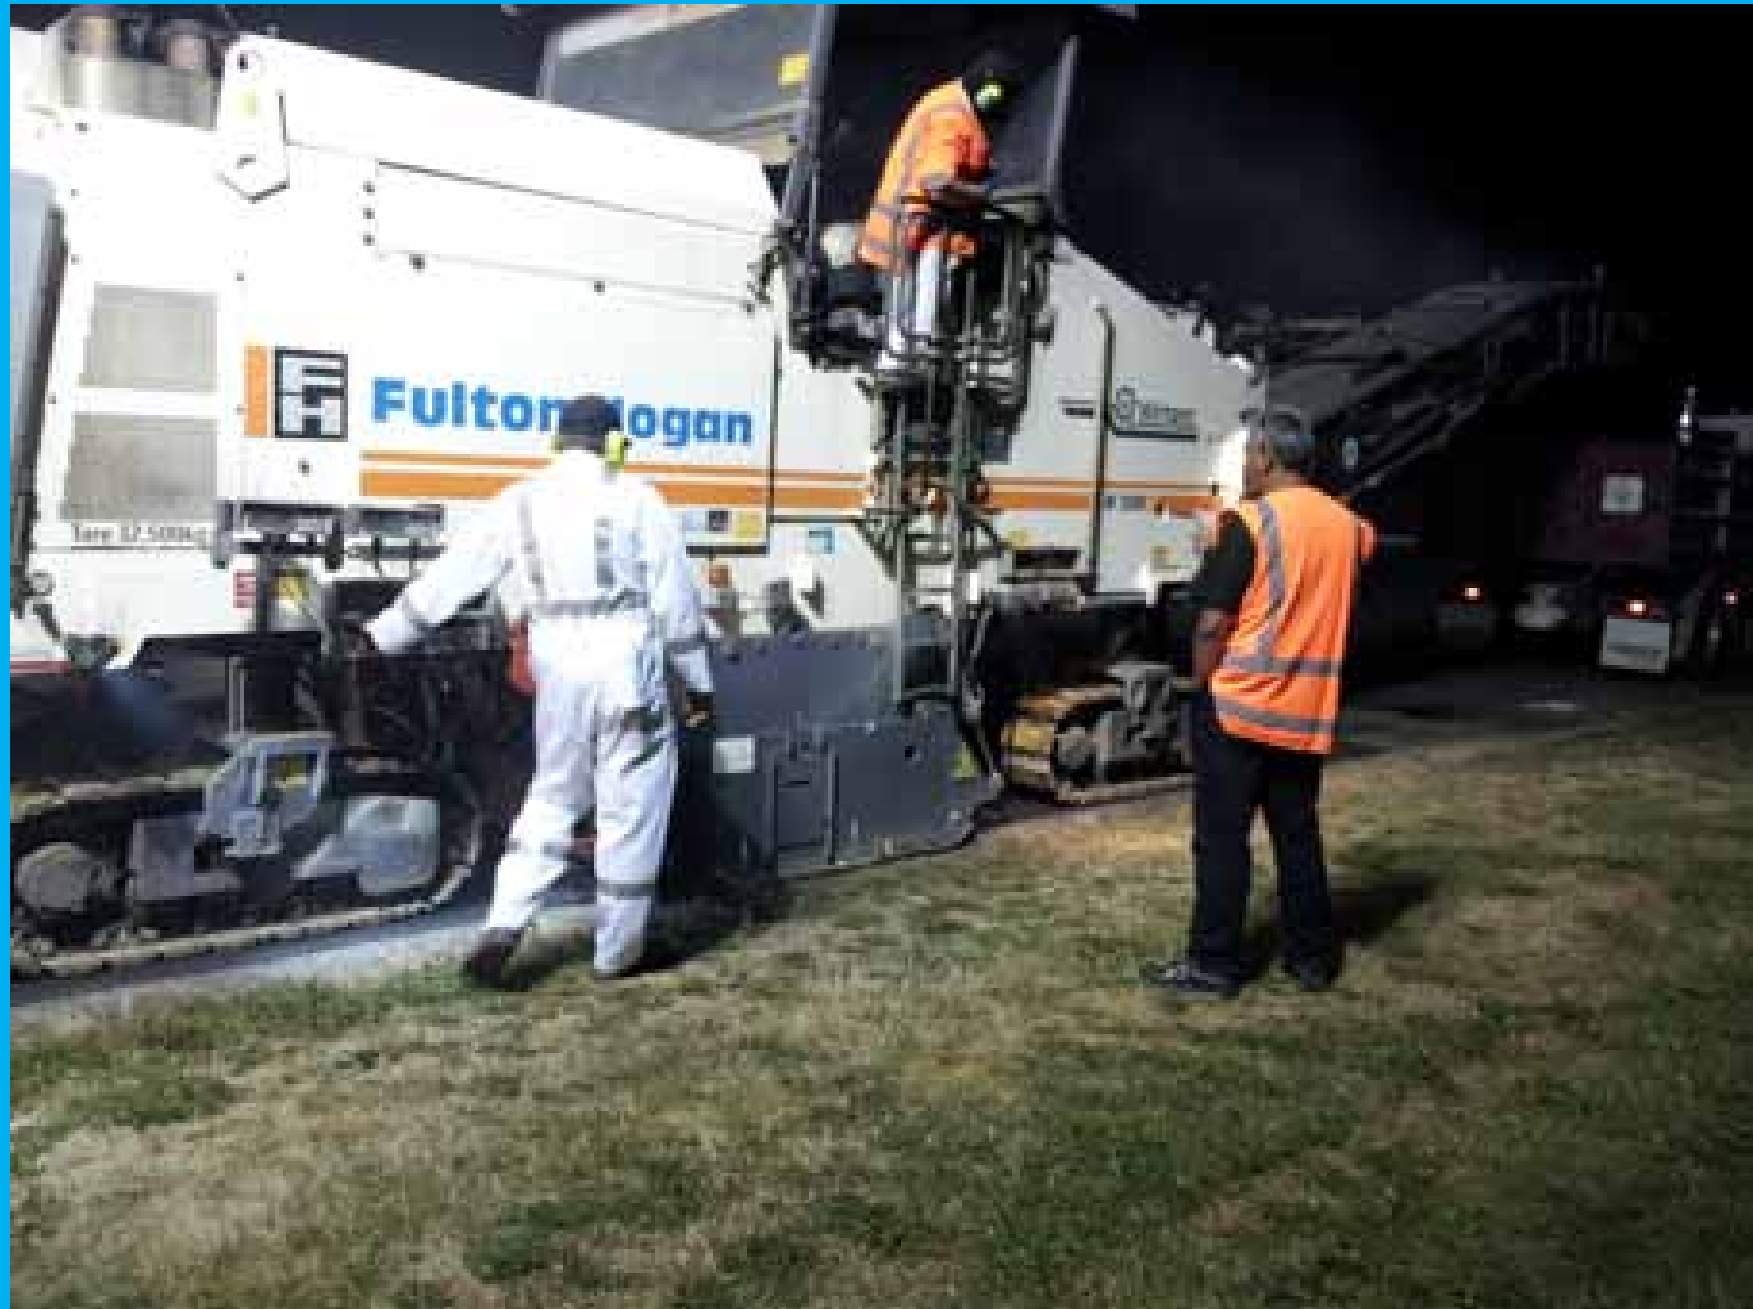
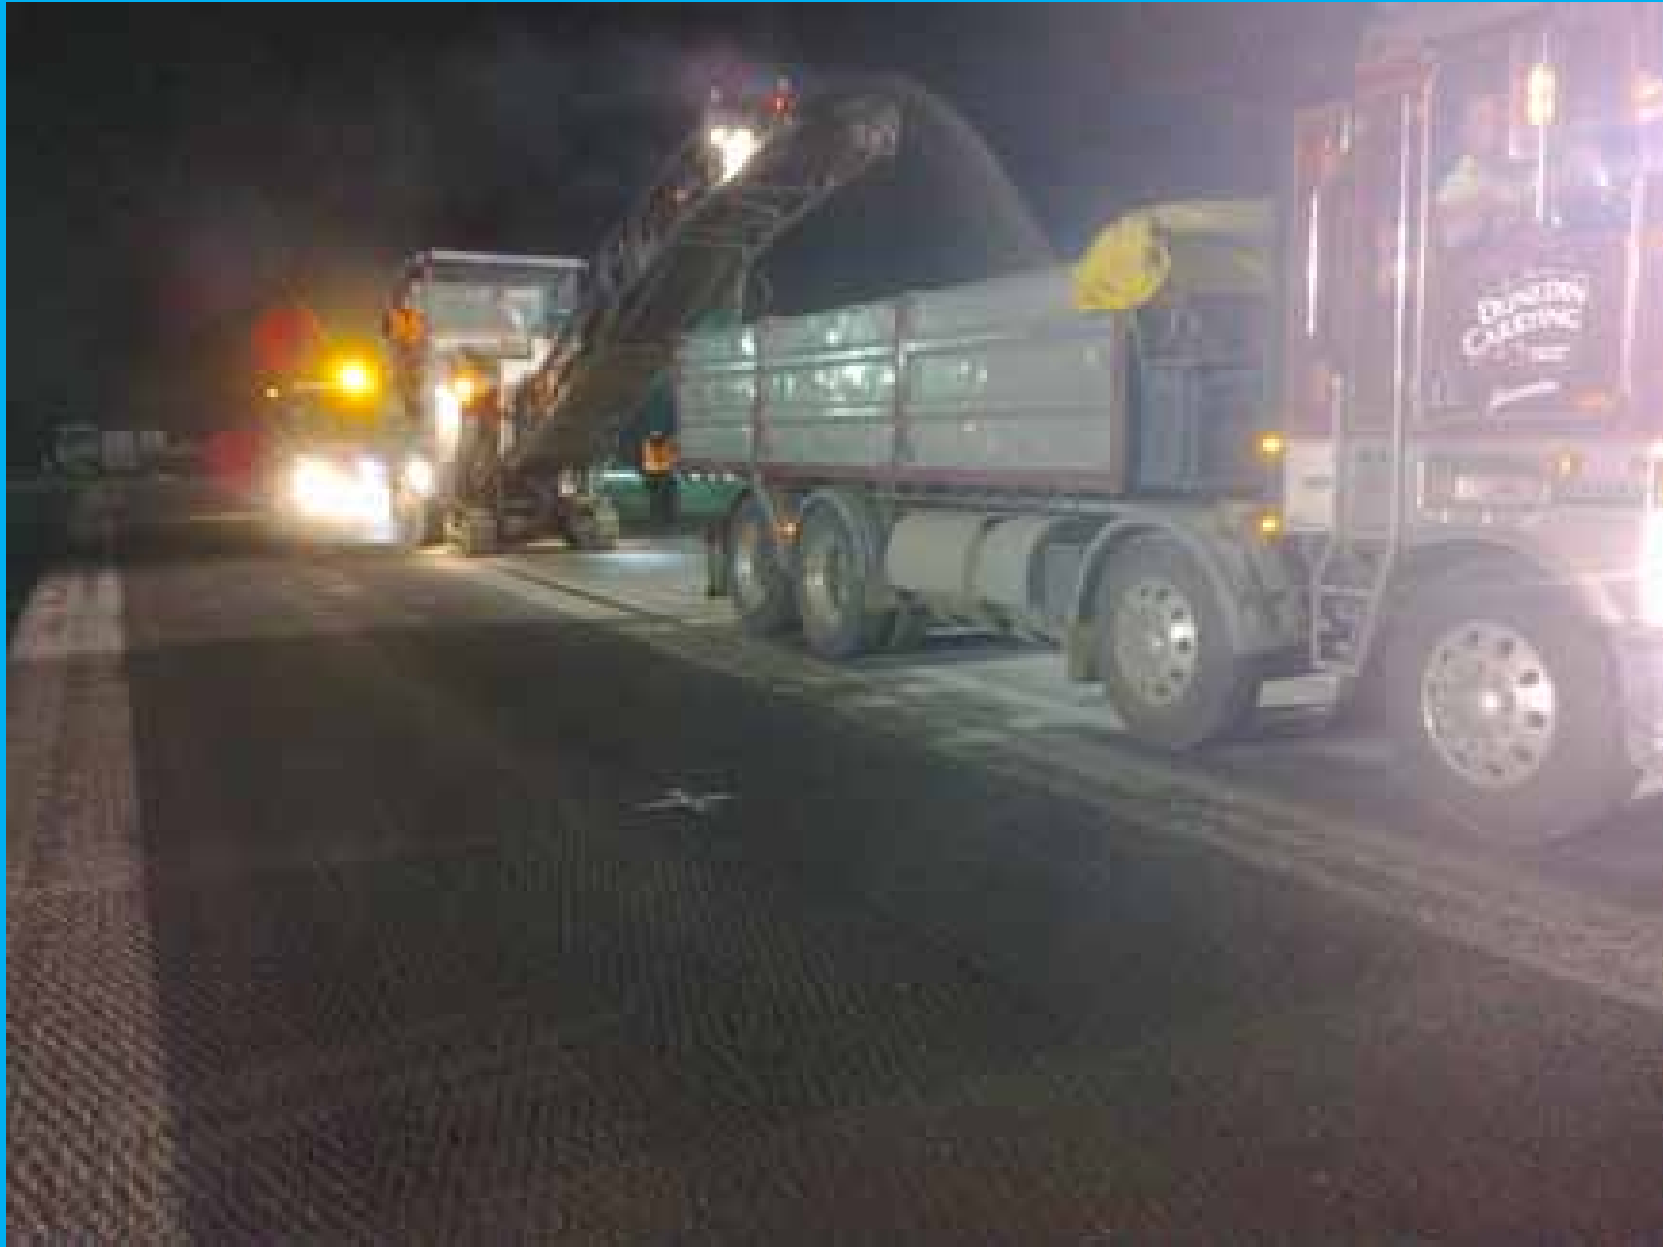
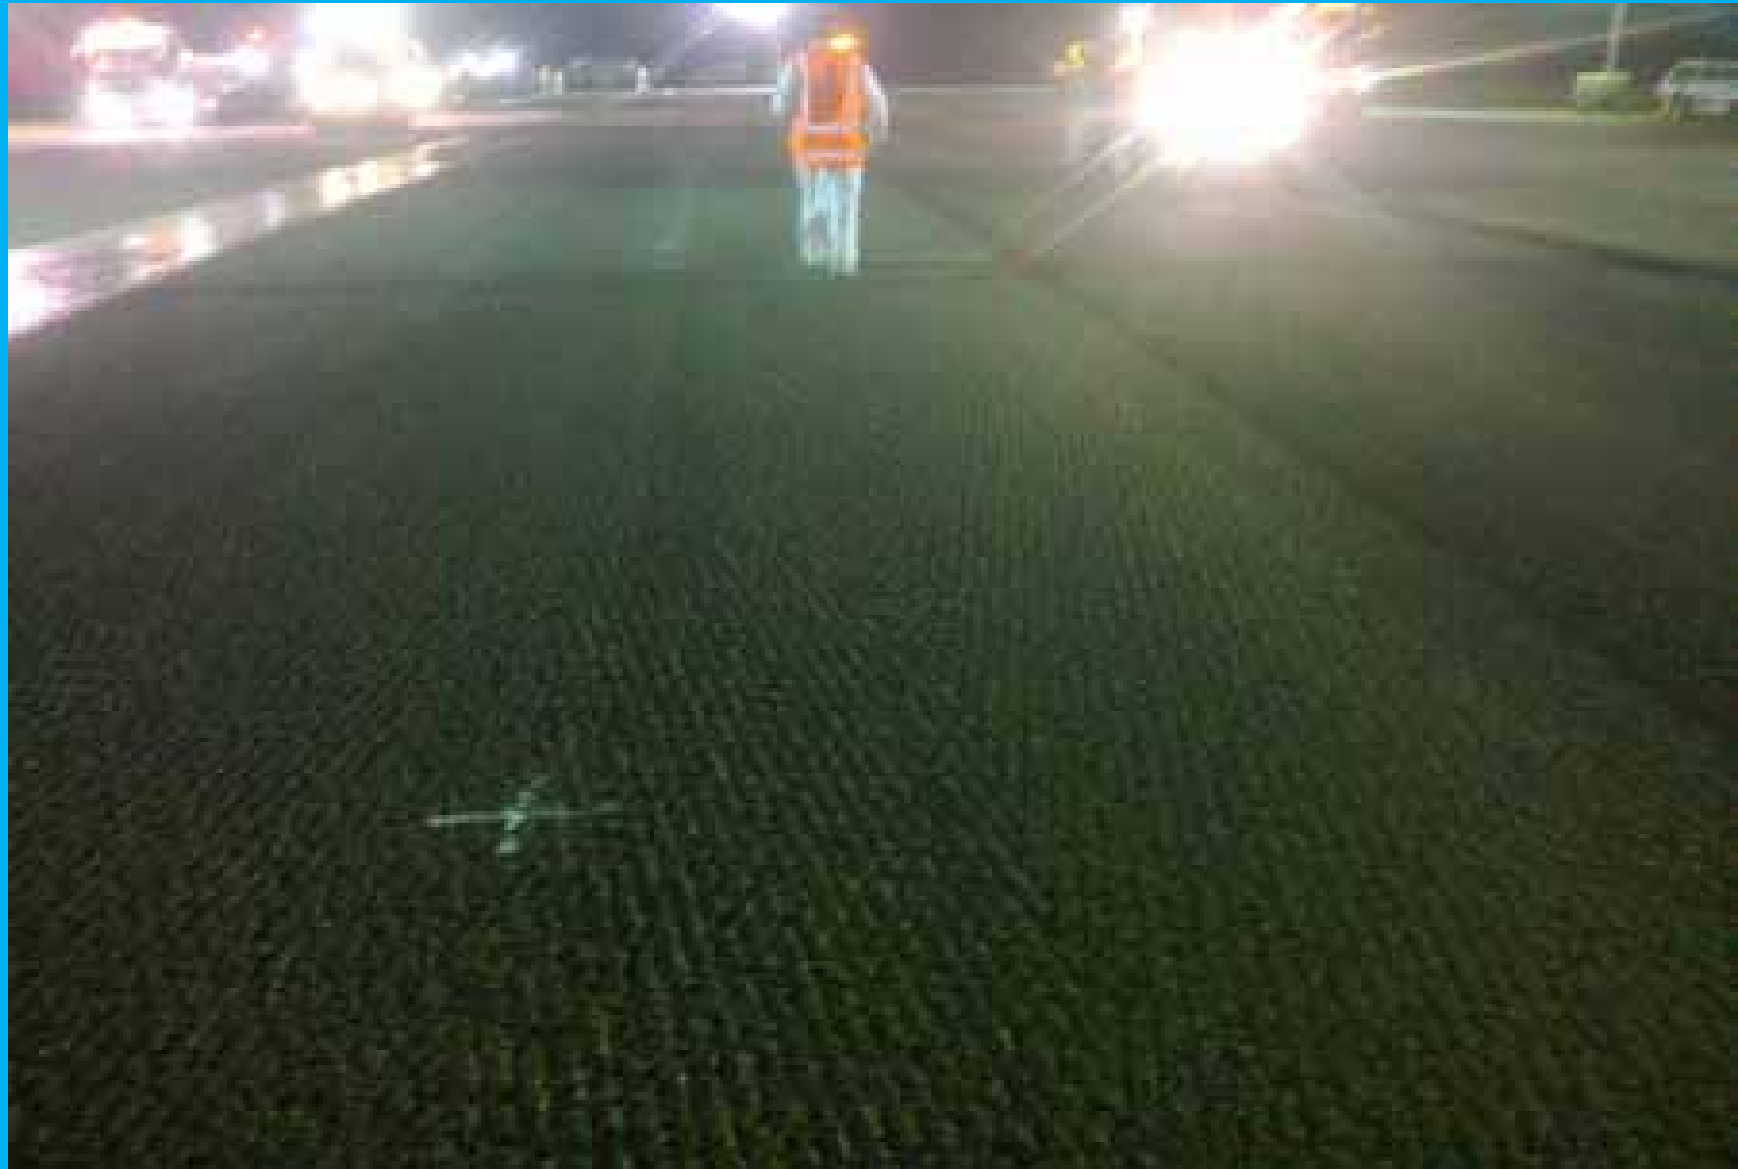
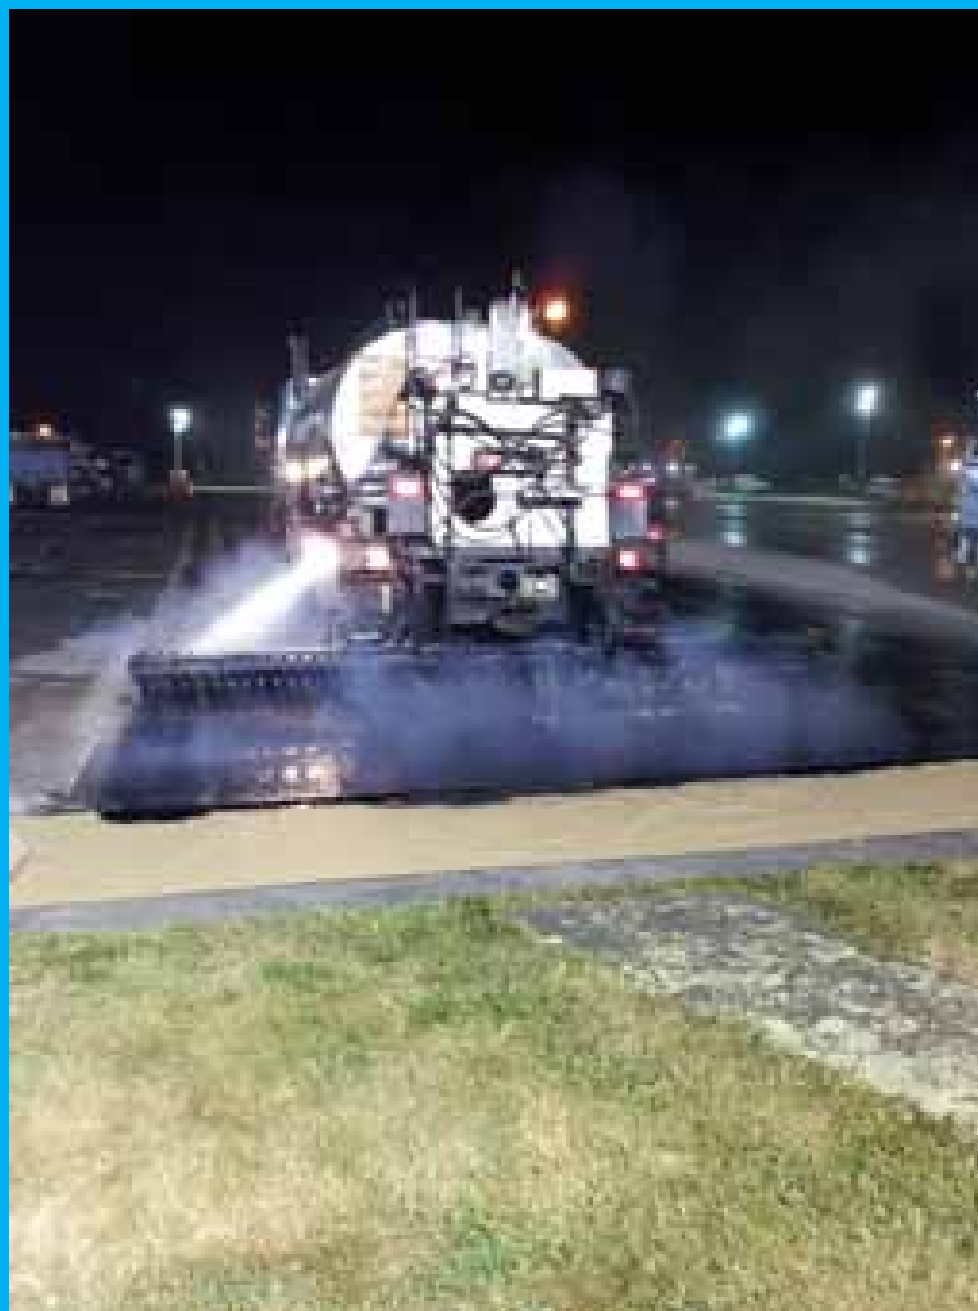
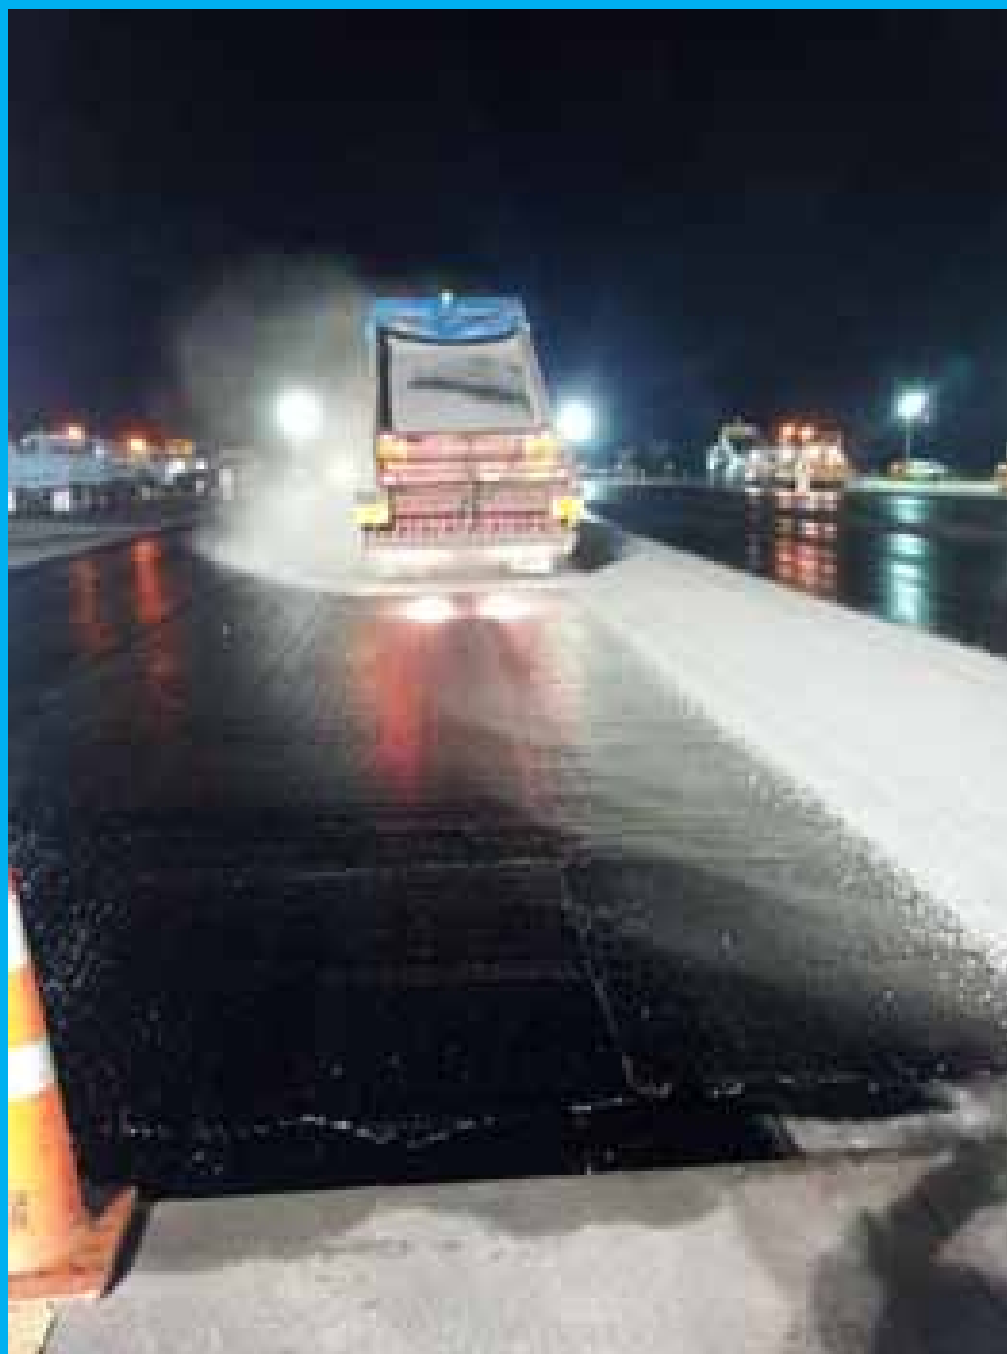
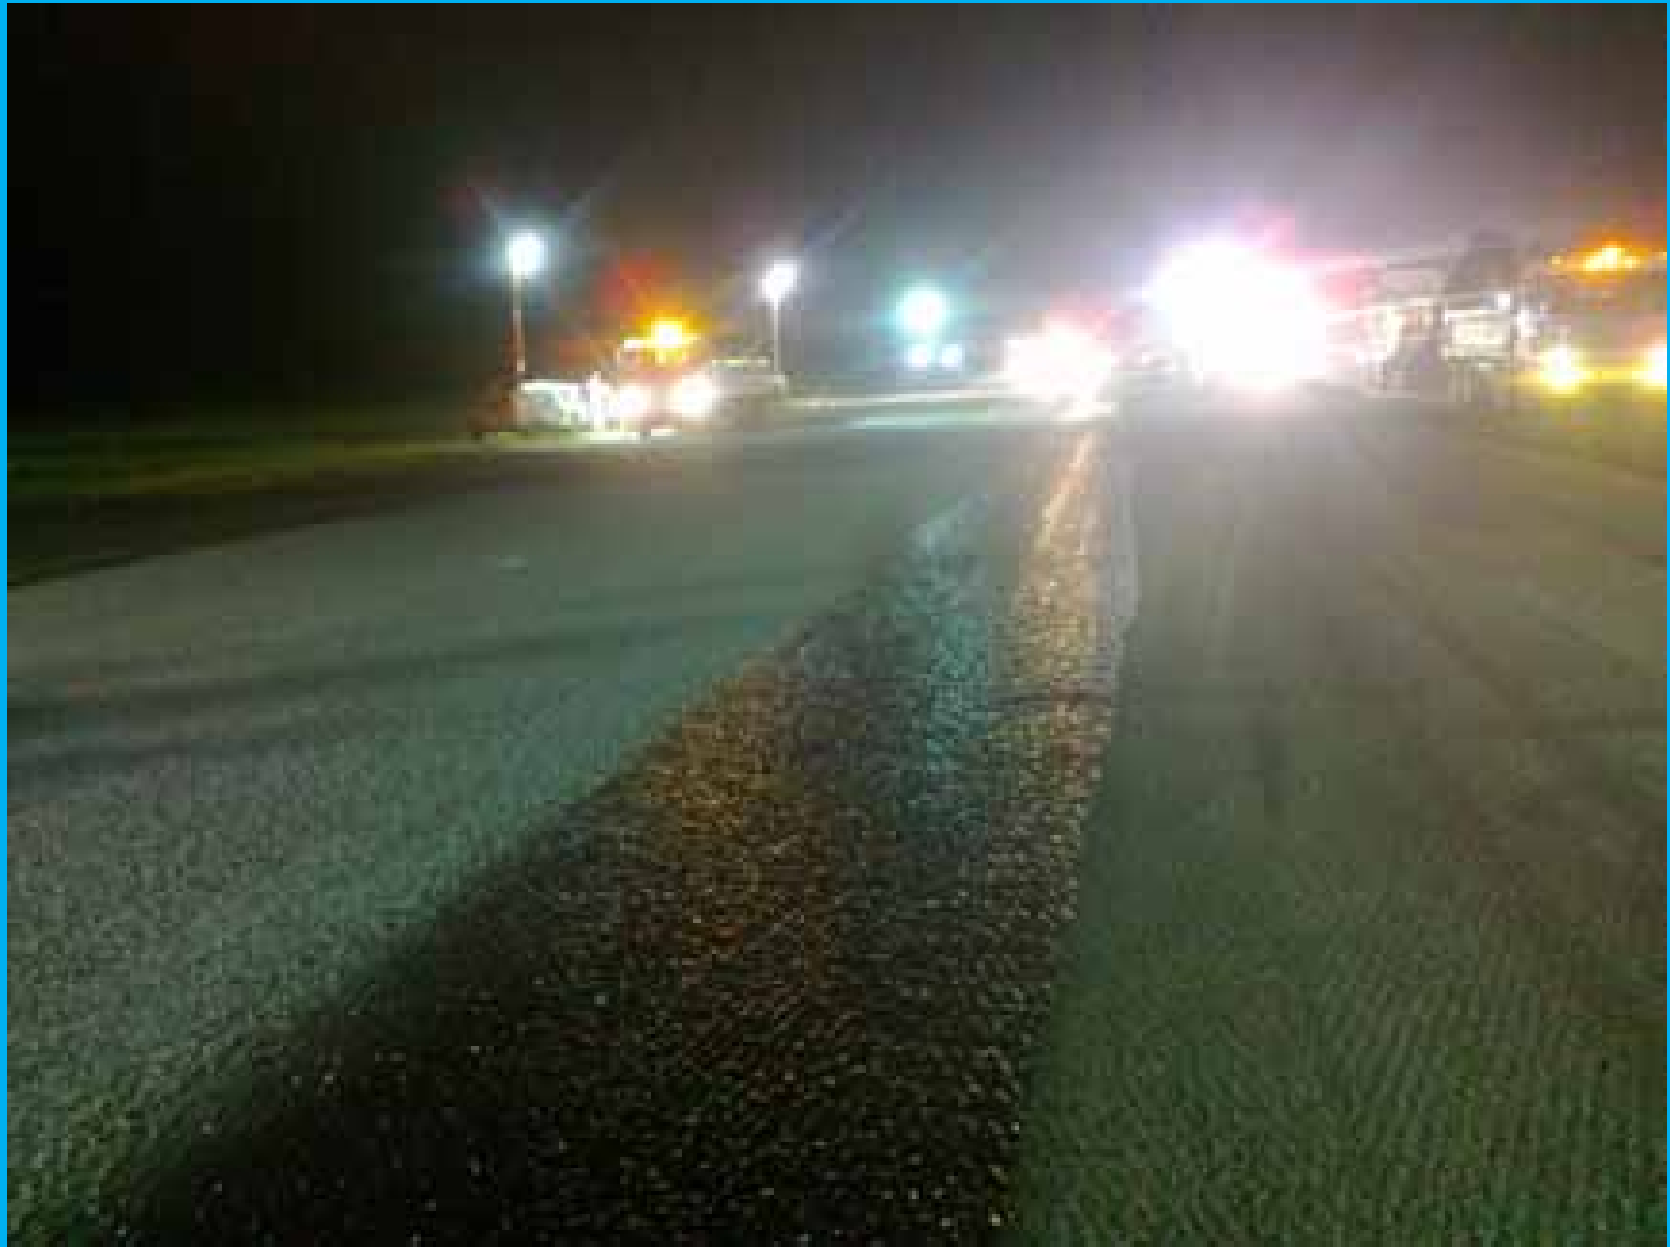
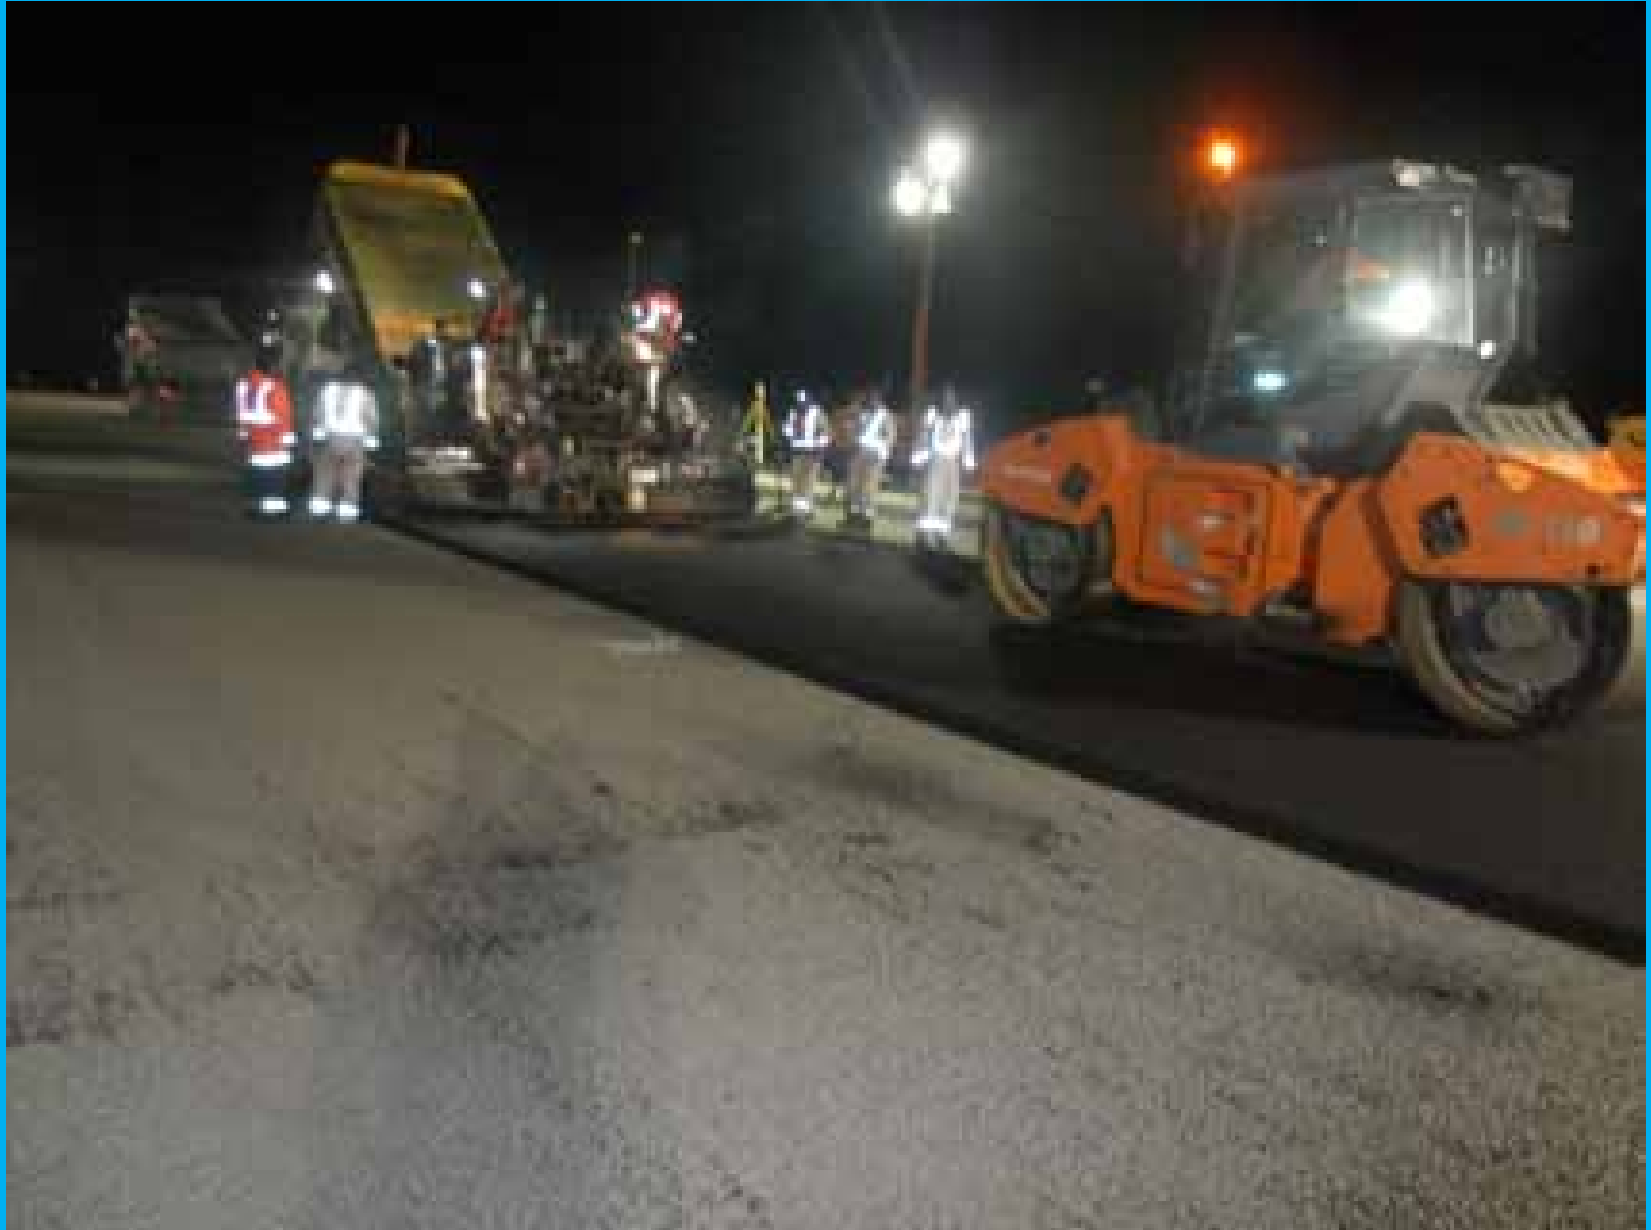
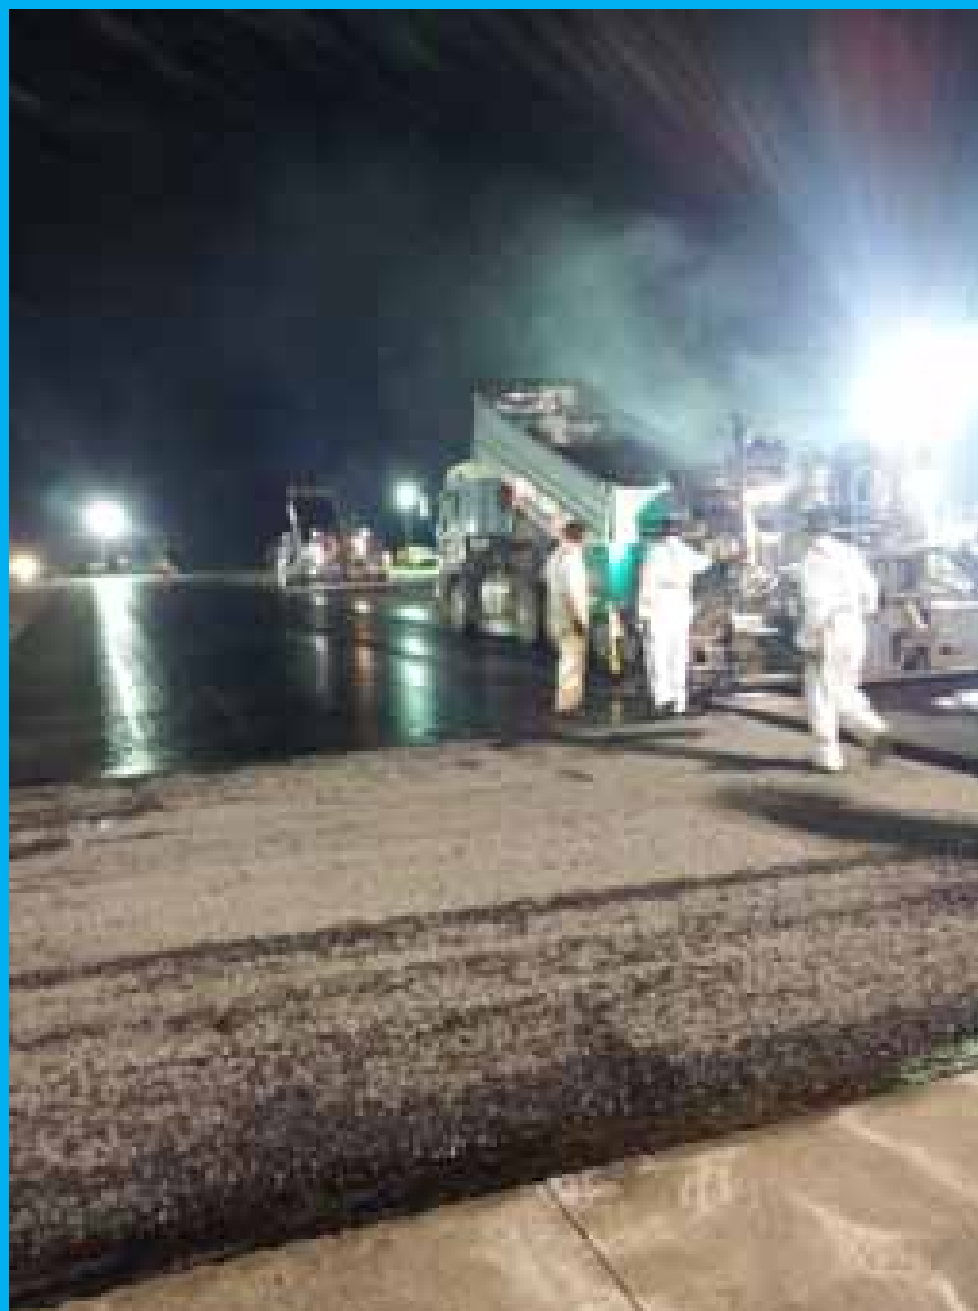
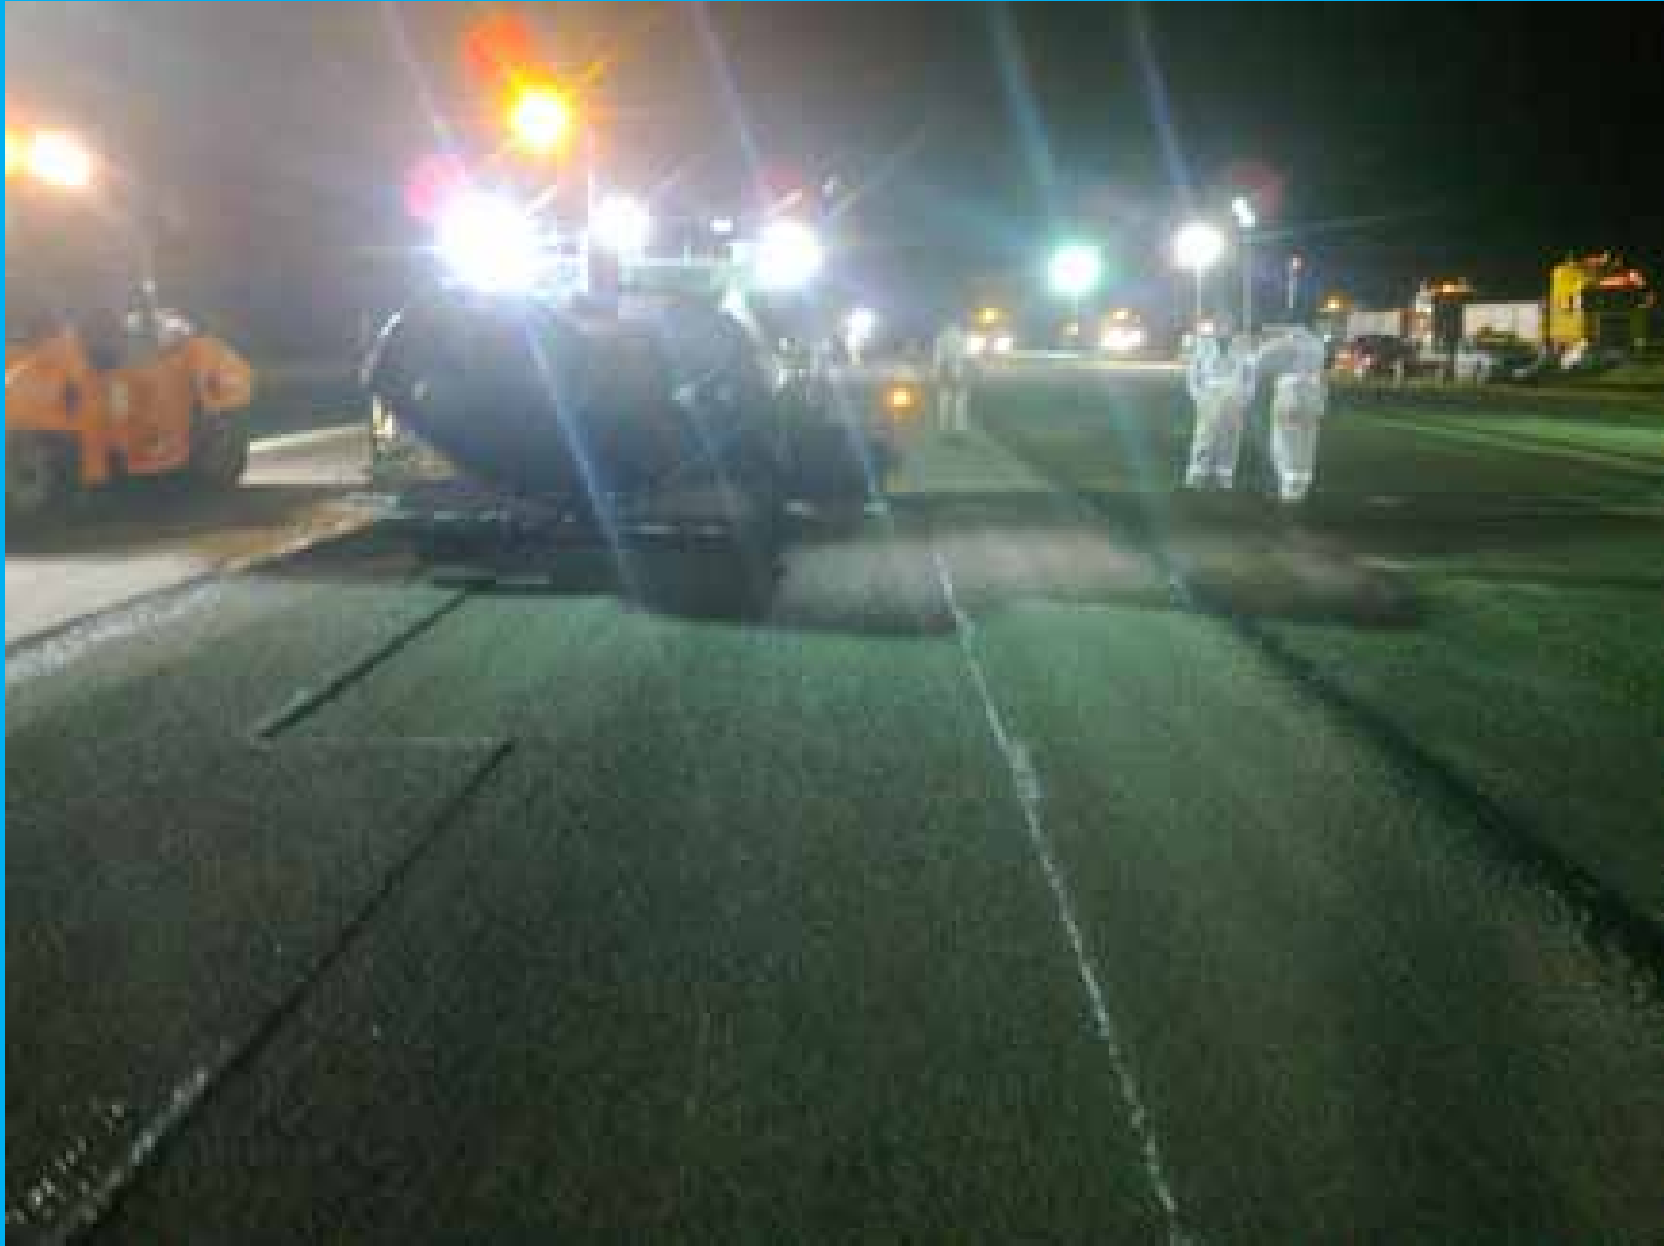
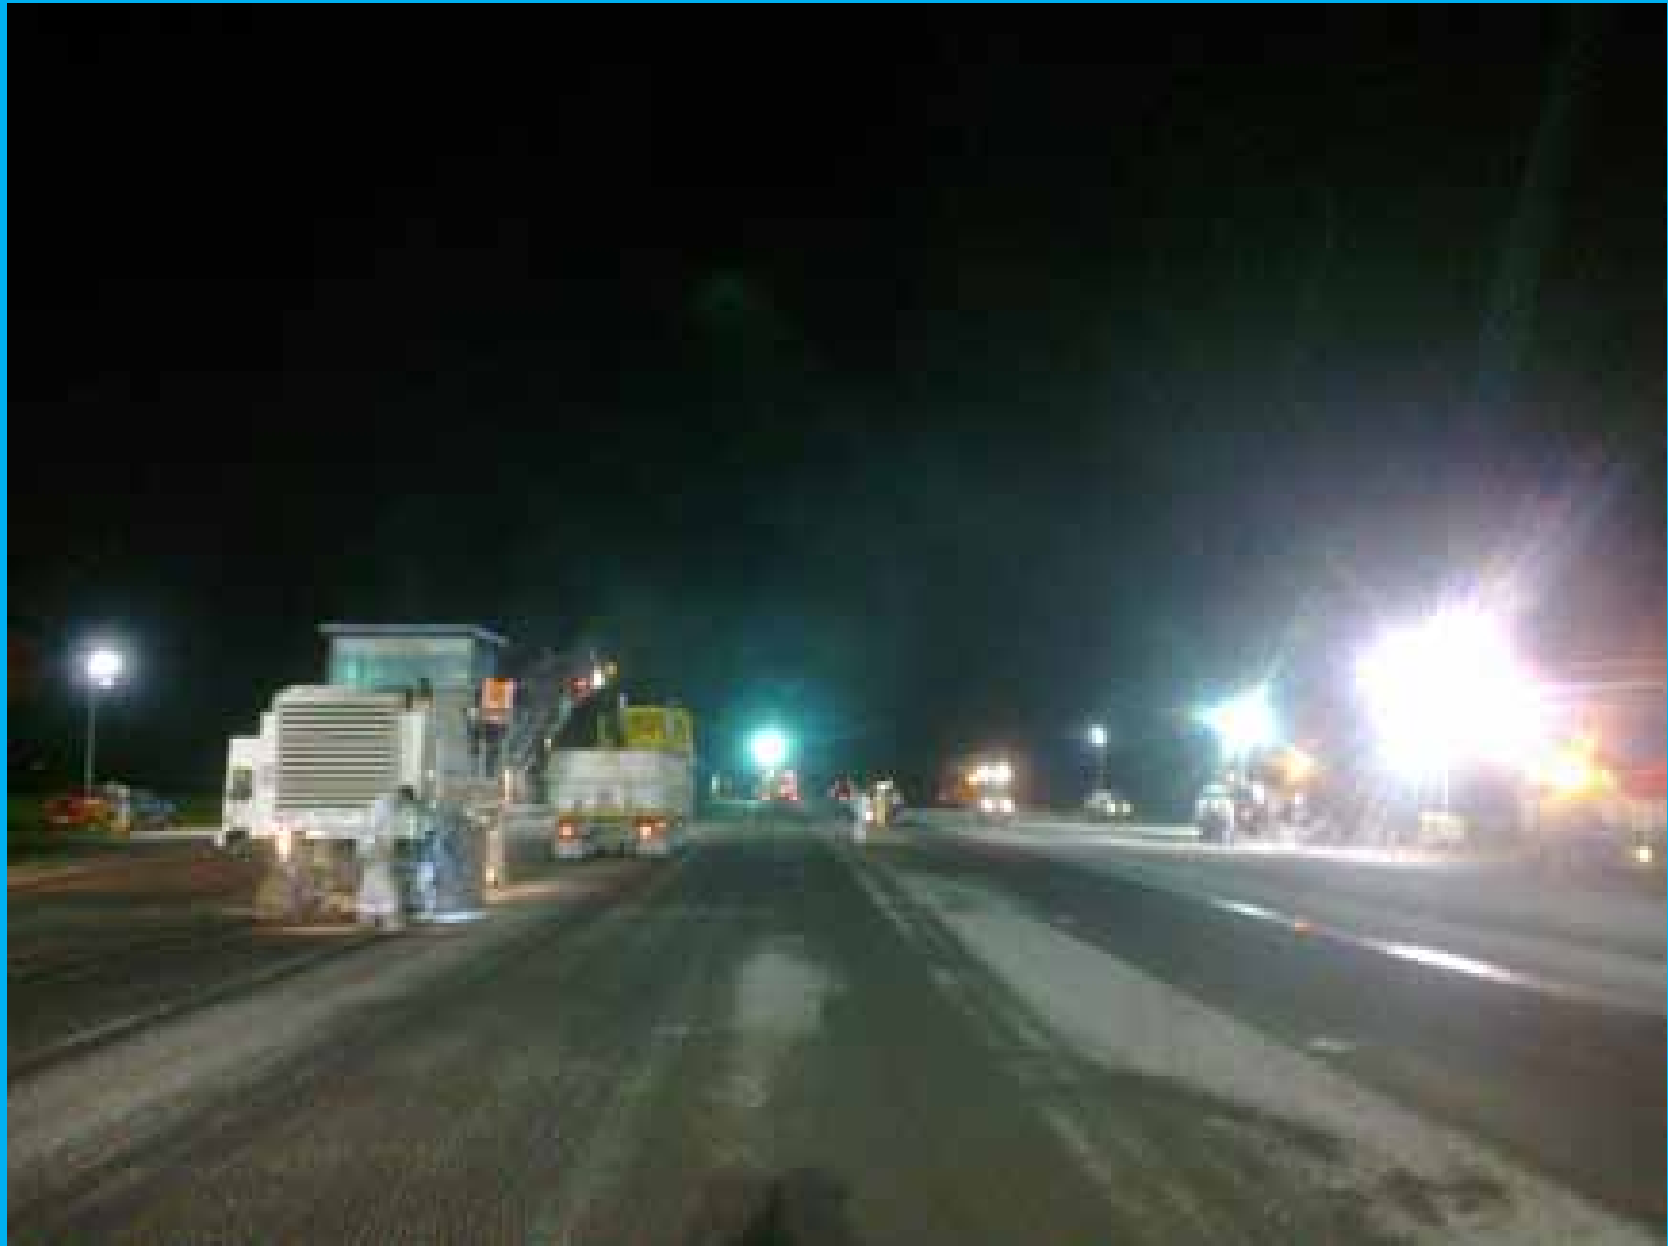
The Process

- Start on far side, Mill goes first. Up to 120m/night including milling out temporary ramps
- Debonding chased out and swept
- When mill reaches centreline membrane applied
- Asphalt applied to deeper milled areas
- Asphalt laid in 4.6m wide runs in echelon (including ramps) and rolled
- At centreline, decision to continue
- Pavement marking
- Emu parade
