SH77 Rakaia  
Gorge Bridge  
No.1

- 55m span wrought iron truss constructed circa 1882
- One of the oldest structures on NZ's State Highway network
- Category 1 Heritage Structure
- Deck replacement and seismic strengthening works currently underway

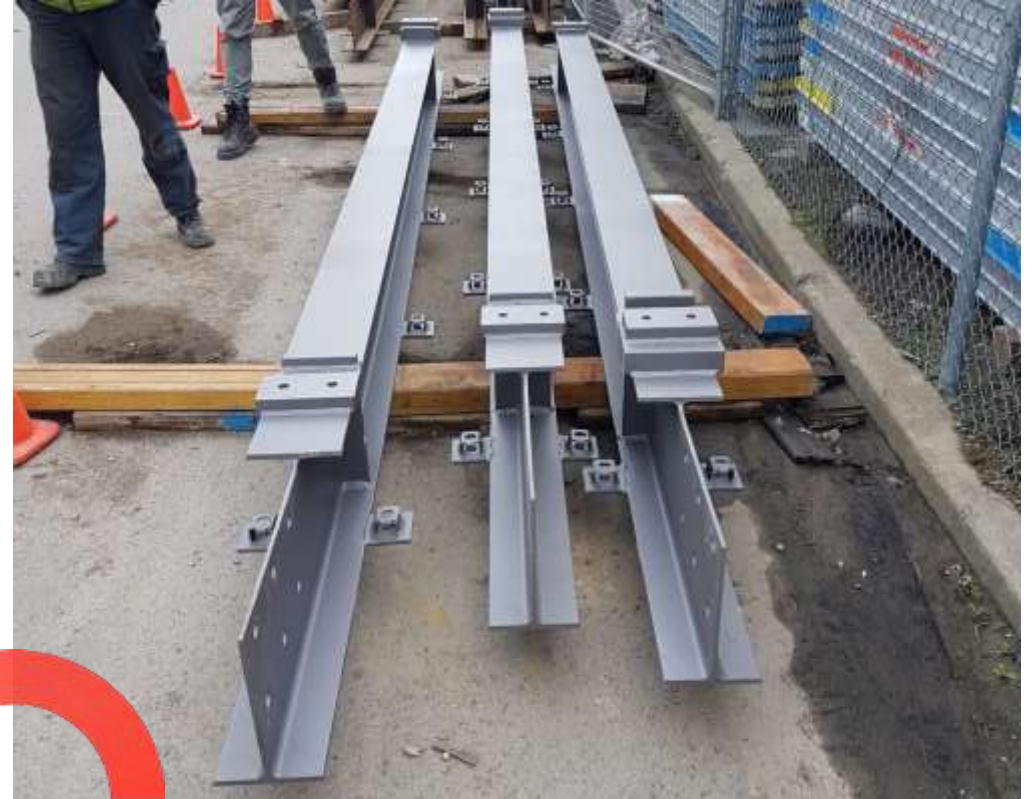
- Modified steel UB transoms
- Laminated Timber Panels (140mm thick)
- BRP road patch surfacing
- 50 year expected remaining life following deck replacement

Steel UB transoms in storage yard (Source: Downer NZ)

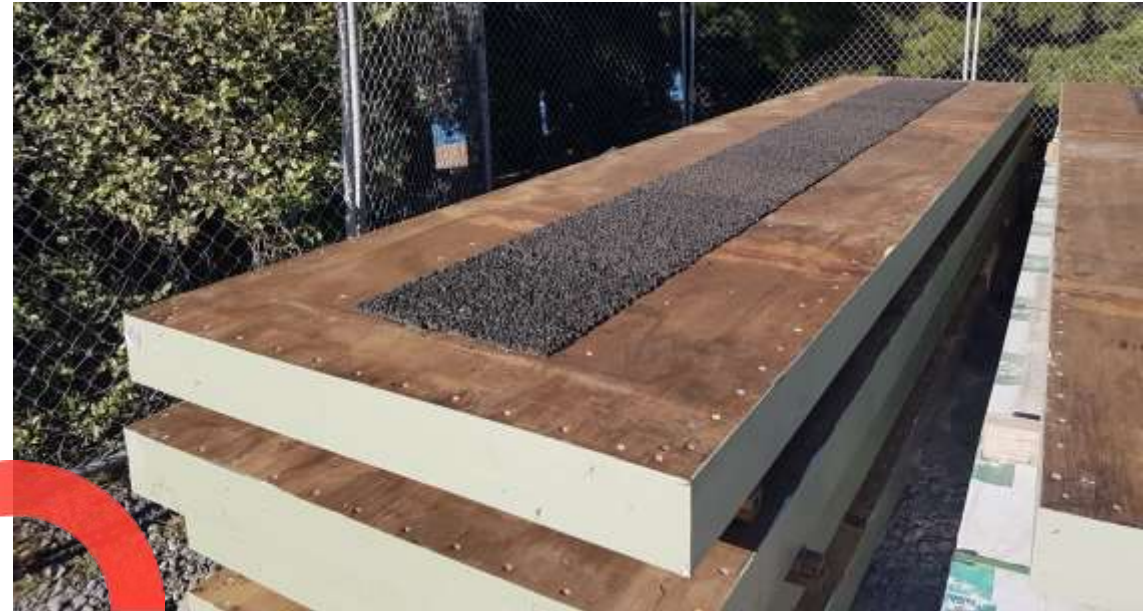
- Modified steel UB transoms
- Laminated Timber Panels (140mm thick)
- BRP road patch surfacing
- 50 year expected remaining life following deck replacement

BRP road patch on Laminated Timber Panel

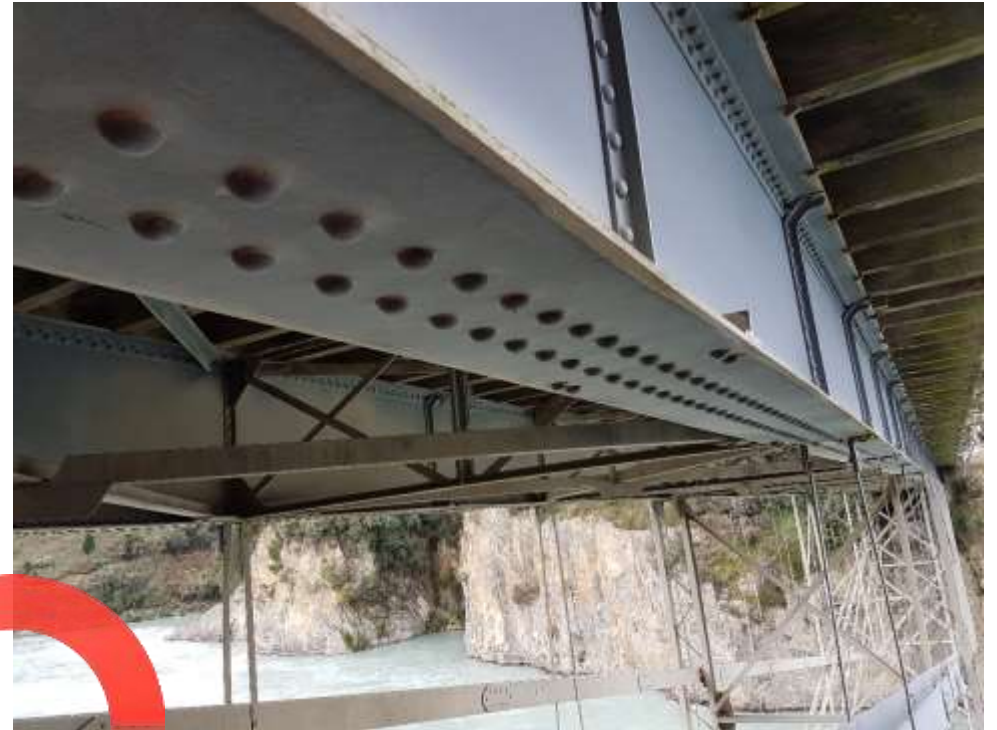
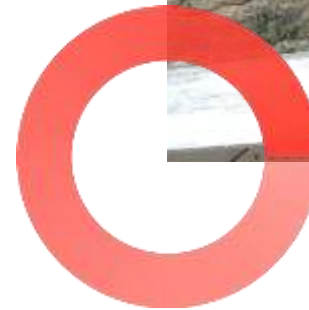
- Riveted girders with rivets protruding through top flange
- Bearing plates with oversized holes used to accommodate rivets

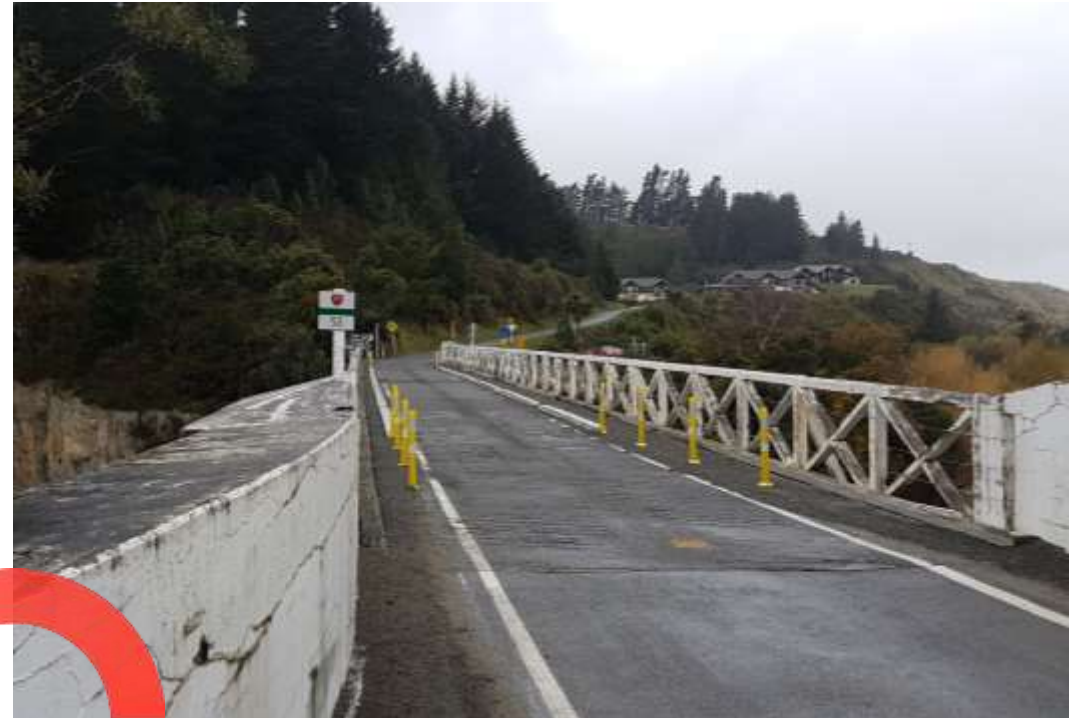
- New deck has a more continuous surface
- Originally, water drained through many gaps between deck planks
- Cross-fall in new deck allows water to drain off edge of structure

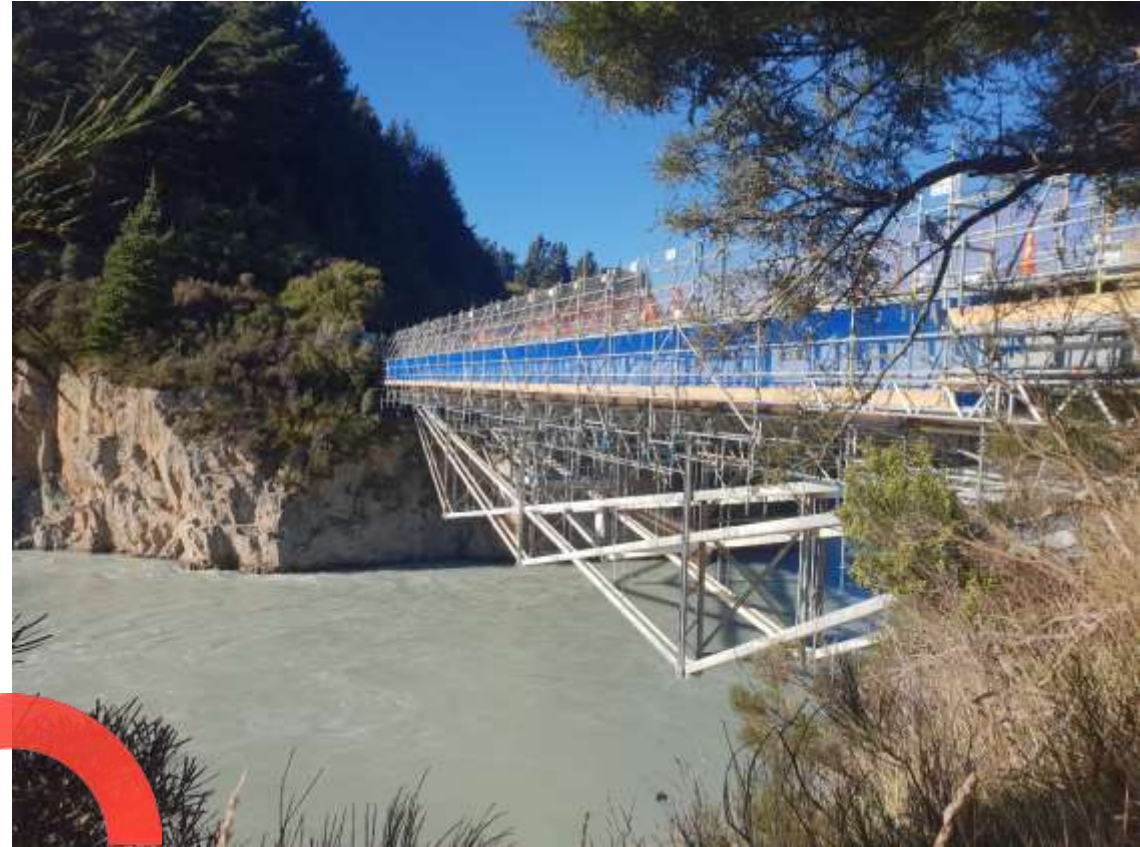
- Deck approximately 16m above river below
- Scaffold installed across entire structure to complete works
- Provides safe access to underside of deck between trusses

Scaffolding of Structure (Source: Downer NZ)

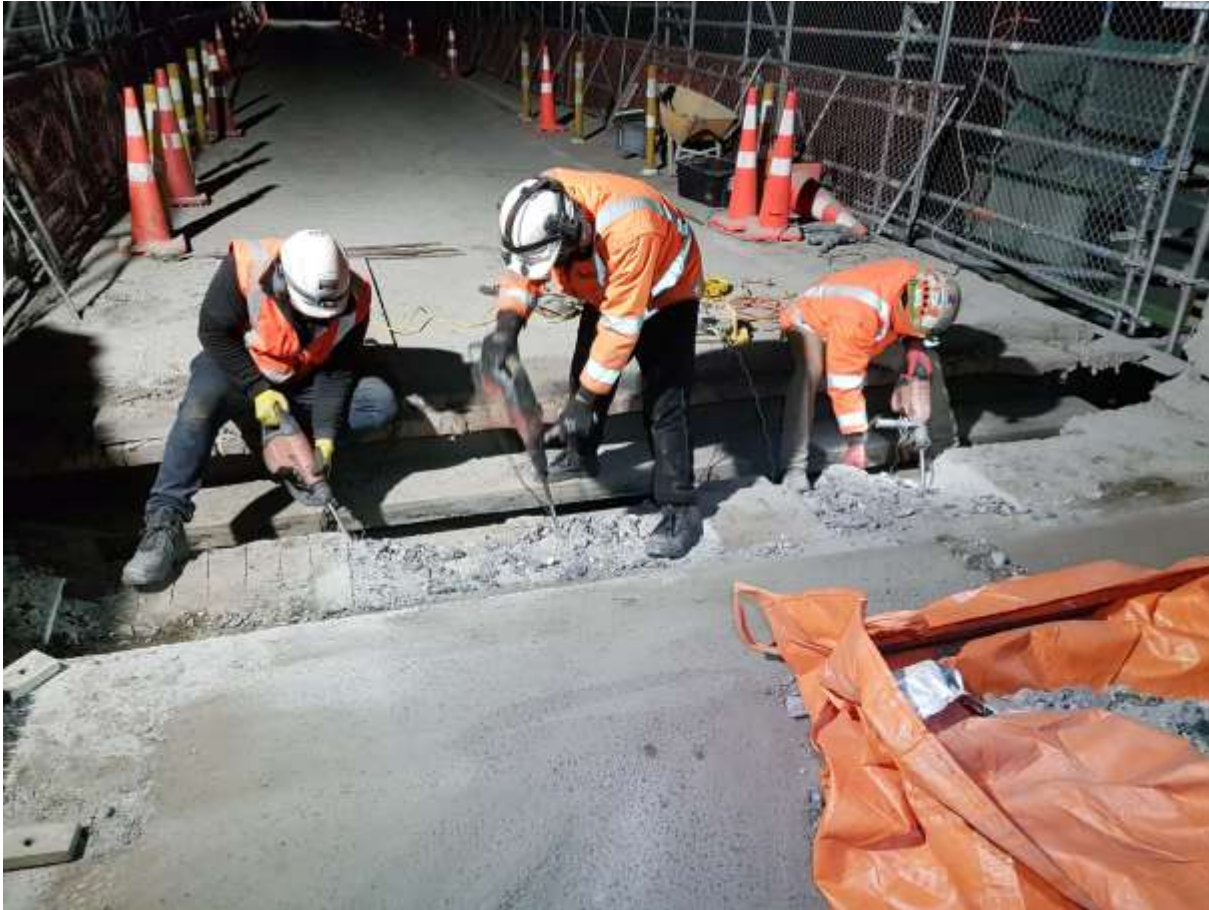
Breakout of headwall at Christchurch end of structure during night closure (Source: Downer NZ)
