**Breathing Life into Hardwood  
Bridge Trusses:  
*A Marriage of Steel and Timber***

**Ian Taylor, David Hutchison Downer EDI Works**

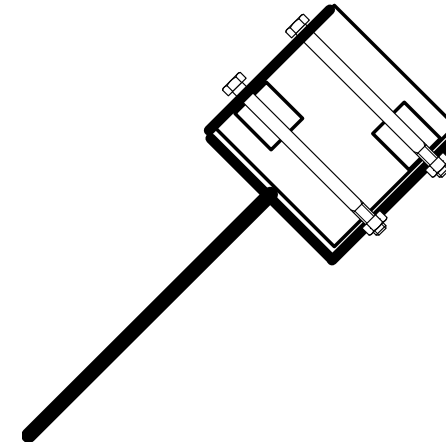
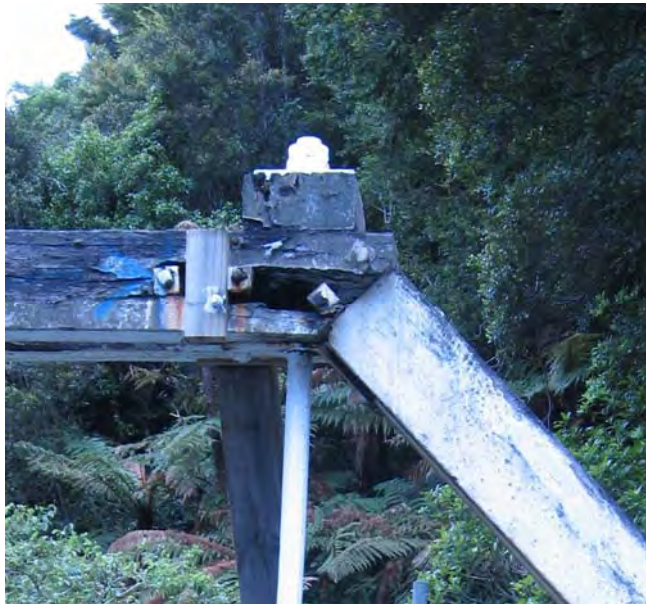
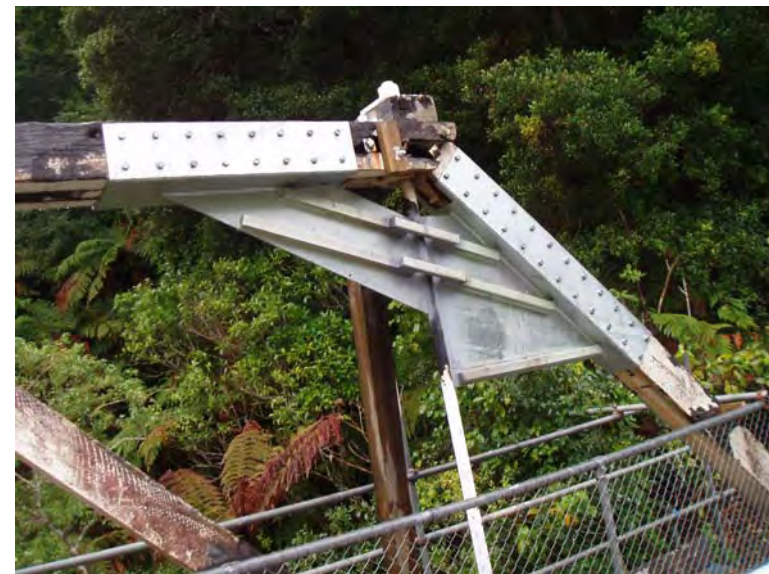
- Main challenge was nodes (joints)
- Some timber ends were seriously decayed
- Objective was to span across ends with steel
